# Dolphinholme Conservation Area Appraisal

Adopted June 2016

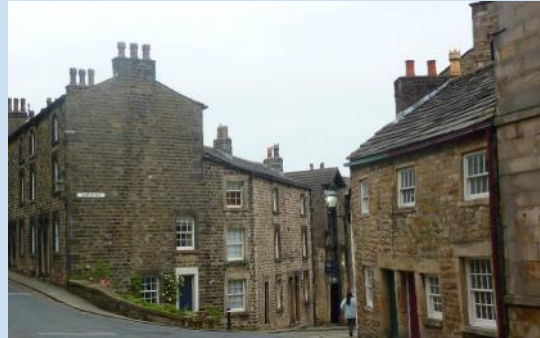
Fig. 1 View of Castle Hill in Lancaster, a collection of Georgian houses.

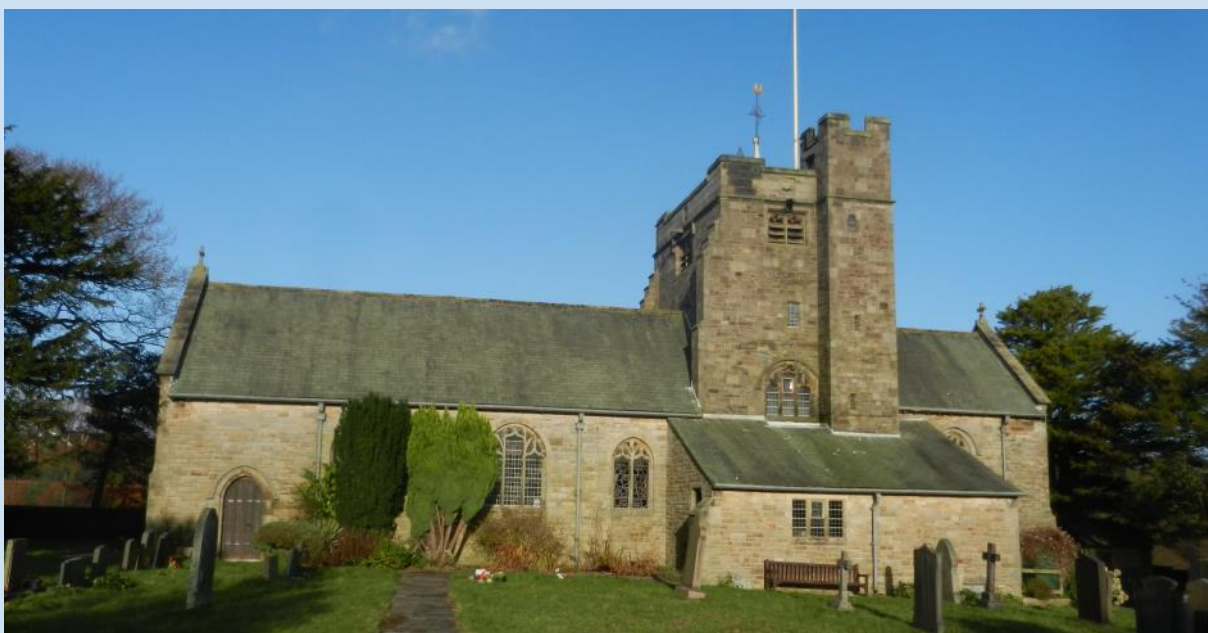
Fig. 2 St Mark's church was constructed at the end of the 19th century in Gothic revival architectural style.

Church, 1897-9 by Austin & Paley. Sneked sandstone rubble with green slate roof, the north aisle now felted. Comprises a nave with north aisle and north porch, a crossing tower with north transept and south lean-to, and a chancel. The north aisle has 4 windows of 2 cusped ogee lights under flat heads. The porch has a doorway with pointed head and hood under a gable of shallow pitch with cross finial. The tower has a stair turret at its south-east corner, buttresses on the east and west sides, a solid parapet raised at the corners, and a slate pyramid roof with weather vane. The bell openings have trefoiled lights under flat heads. On the south side, above the lean-to roof, is a 3-light window with segmental head and hood. The chancel has a 2-light window with pointed head on both the north and south sides. The east window is of 5 lights and includes reticulated tracery. The south nave wall is of 3 bays, having windows of 3, 3 and 2 ogee-headed lights under pointed heads. To the west is a doorway with pointed head. Interior. 3-bay nave arcade has segmental arches, hollow-chamfered in 2 orders, and octagonal piers. The crossing arches are pointed, with the hollow chamfers dying into the responds. The boarded nave roof has 6 trusses with braced raised tie beams, collars, and queen struts. The chancel has a trefoiled piscina and a roof with raised tie beam, king post, and arch-braced collar. It is boarded at arch-brace level.

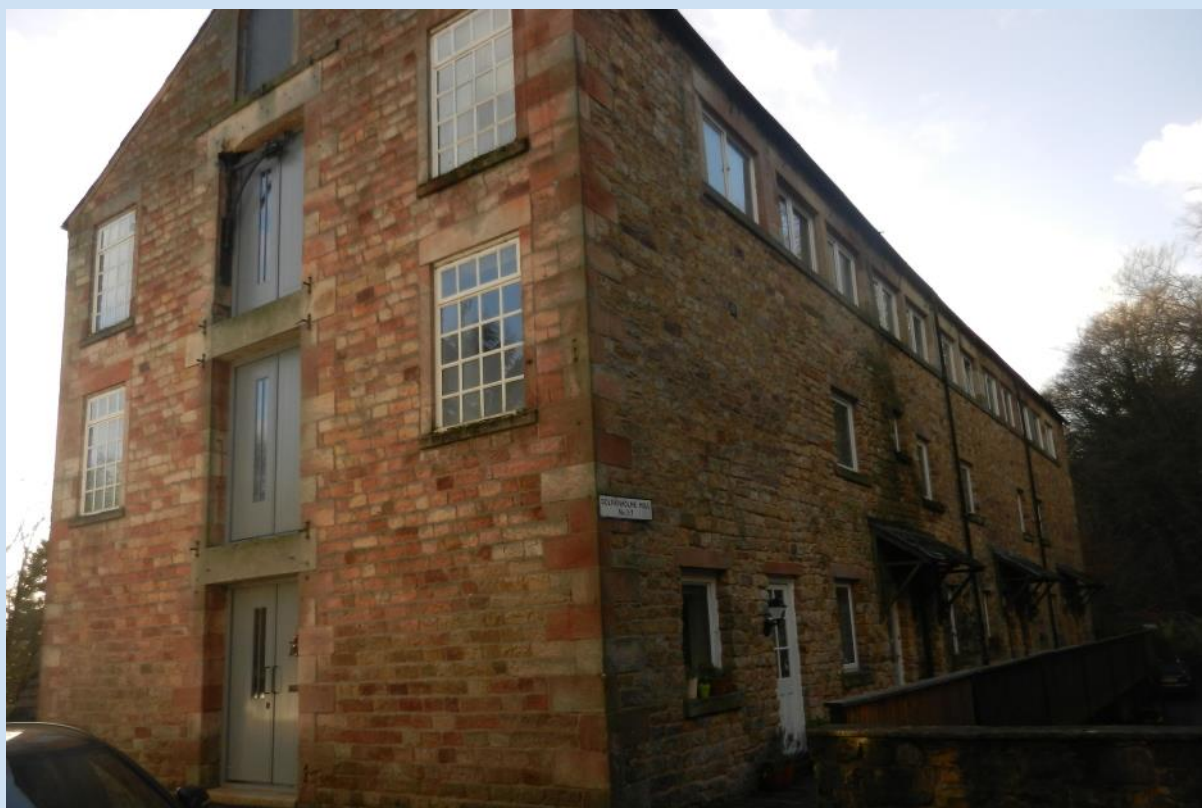
Fig. 4 Dolphinholme Mill, formerly the warehouse in the 19th century. The building was used as a memorial for those who died in the First World War in the interwar period and was converted to housing in late-20th century.

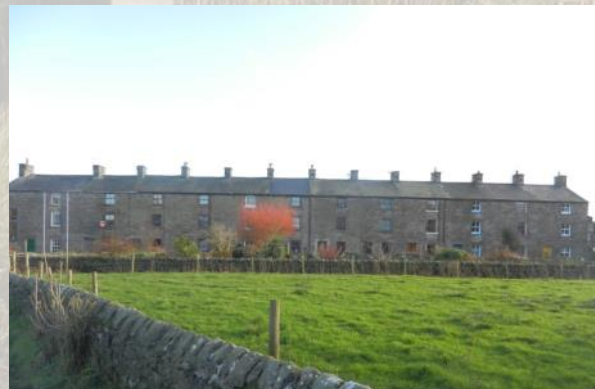
Fig. 7 Corless Cottages are three storeys, built in 1796. They were constructed to house mill workers; two families lived per property.

Row of mill workers' houses, said to be built for Clarkson in 1796. Sandstone rubble with slate roof. 3 storeys. Each house of one bay, having windows with plain stone surrounds. Most are sashed, but some have modern frames. Each house has door to left, with plain stone surround, and chimney to right. The left-hand house, now part of the post office and shop, has sashed windows with glazing bars on the ground and 1st floor. Its door is now blocked to form a window. At the left is a stair window with plain stone surround. Adjoining to the left, of 2 storeys but of the same build, is the original part of the shop. It has a modern window with plain reveals on the 1st floor. Its end wall has a modern shop front on the ground floor and 2 modern windows with plain stone surrounds on the 1st floor. At the rear the houses are of one bay with a door to the right.

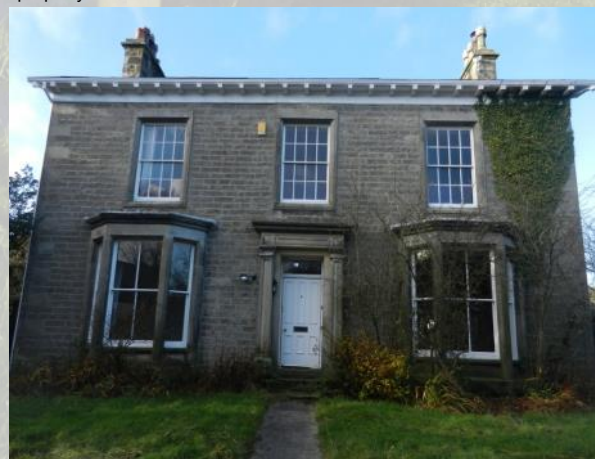
Fig. 8 St Mark's Vicarage was built in the late-19th century in Victorian eclectic style with Doric columns and two canted bay windows.

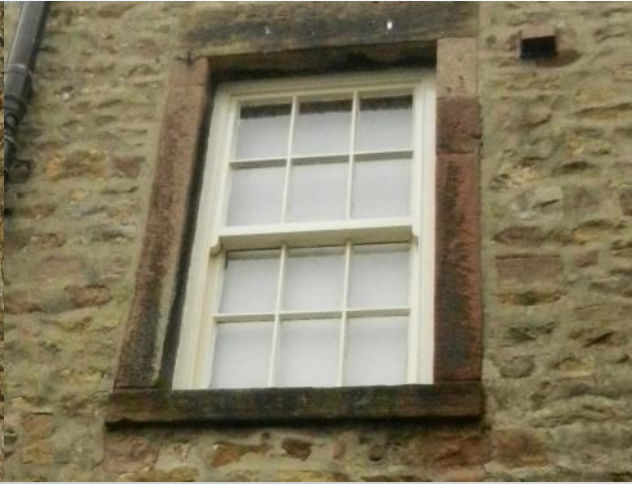
**Fig. 10** Window at Corless Cottage is a traditional timber six-over-six paned sliding sash.

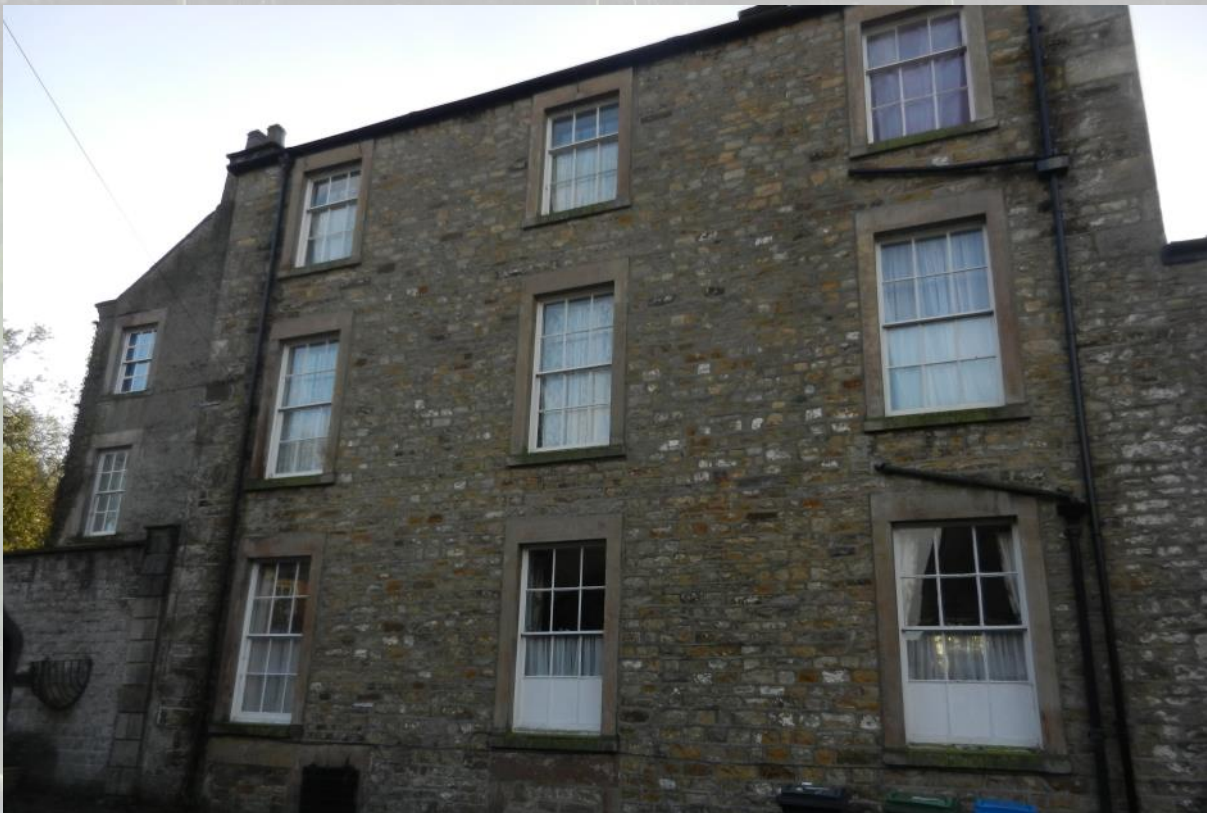
**Fig. 11** Woodcock Hall dates from 1800, it is constructed in local sandstone rubble walling and grey slate roof. It shows influence of national architectural styles of the Georgian period as it is designed in a simple Georgian style with symmetrical façade.

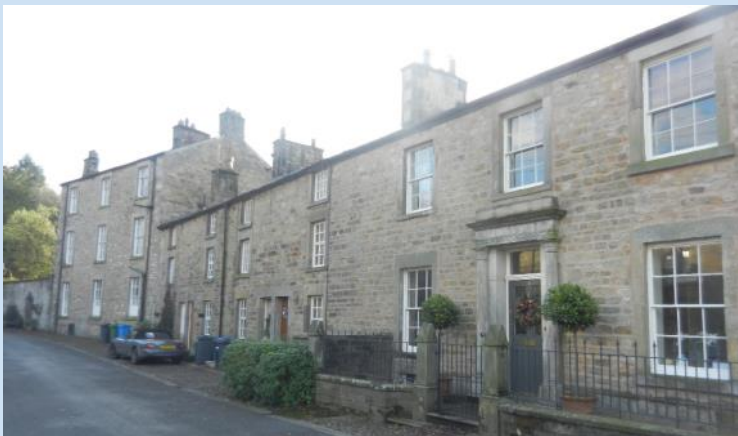
Fig. 12 Derham House in the foreground has a porch with Doric columns and traditional six-over-six paned sliding sash windows. The house is enclosed by a low stone boundary wall with railings.

NETHER WYRESDALE WAGON ROAD SD 55 SW 2/175 Lower Dolphinholme 17-4-1967 No.2 (Derham House) with gas lamp attached GV II House, c.1800. Sandstone rubble with tile roof. 2 storeys, 3 bays. Windows sashed with glazing bars and stone surrounds. Door, in central bay, has doorcase of 2 attached Doric columns. Roof hipped at right. Chimneys to left and set back to right. Right-hand return wall has large tripartite window, sashed with glazing bars and with plain stone surround and flat-faced mullions. On the 1st floor are 2 sashed windows with glazing bars and plain stone surrounds. Attached to the northern corner of the building is a gas lamp on an iron bracket, restored to working order in 1984. Derham House was occupied by the manager of Dolphinholme worsted spinning mill. Gas lighting was installed in the mill in 1811 and also used to light the village street, making Dolphinholme one of the first villages to be lit by gas.

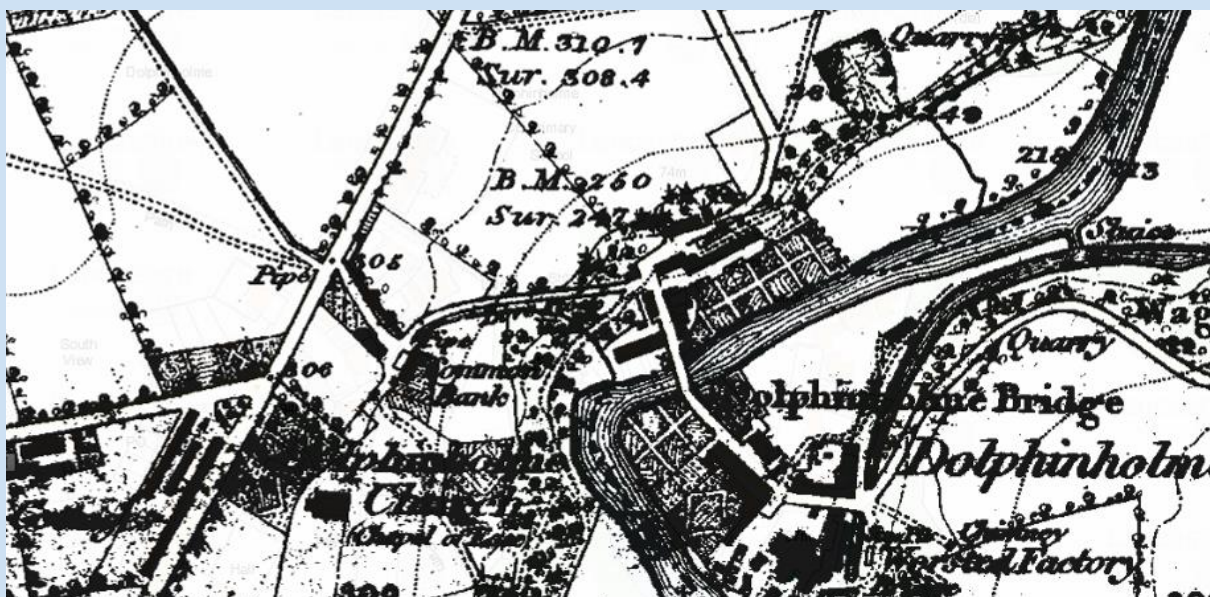
Fig. 13 1840s map Dolphinholme which shows the village at its industrial peak as the mill is still in use. Dolphinholme Church is located opposite Corless Cottages.

Despite this decline, there was a growth in public and religious buildings constructed in the 19th century which were funded by the owners of the mill. In 1839, the proprietors built a church for the community opposite Corless Cottages, which is visible on the 1840s OS map as 'Dolphinholme Church'. It is reported to have been very large, seating 668, but it was not consecrated and when the mill did eventually close so did the church. Additionally, the owners founded Dolphinholme Church of England Primary School in 1865. In the 1860s, the Cookes and Margerisons took over the mill and began to use the machines for cotton which continued to be used until 1867 when the mill was eventually closed. Between 1897-9 St Mark's Church was designed in a Gothic-revival style by local architects, Austin & Paley, costing around £3000.

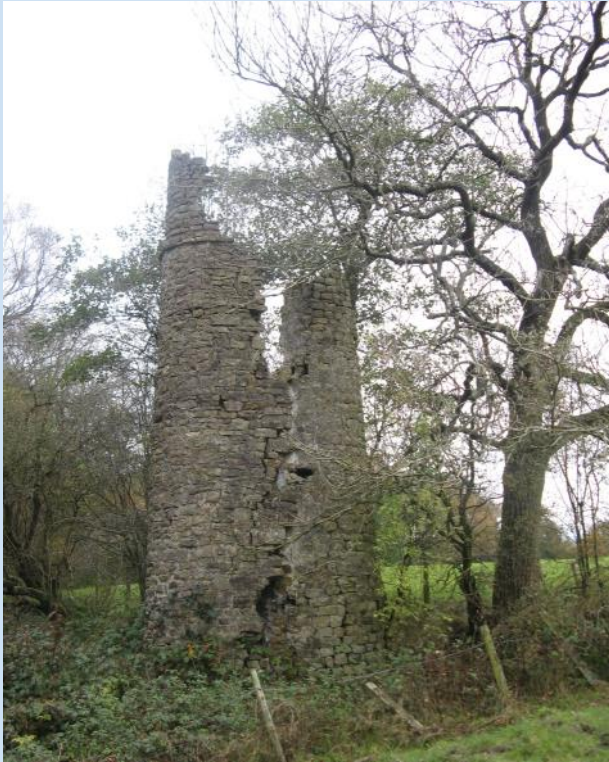
**Fig. 14** The chimney stack was built in the early-19th century to improve efficiency of the fire and draught in the mill.

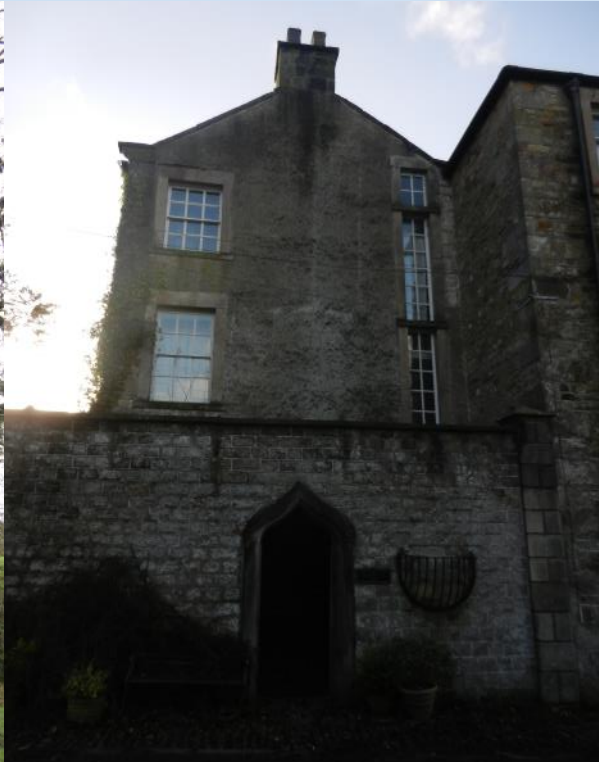
**Fig. 15** Old Mill House, dates from 1800. The boundary wall also dates from 1800, with an ogee headed doorway,

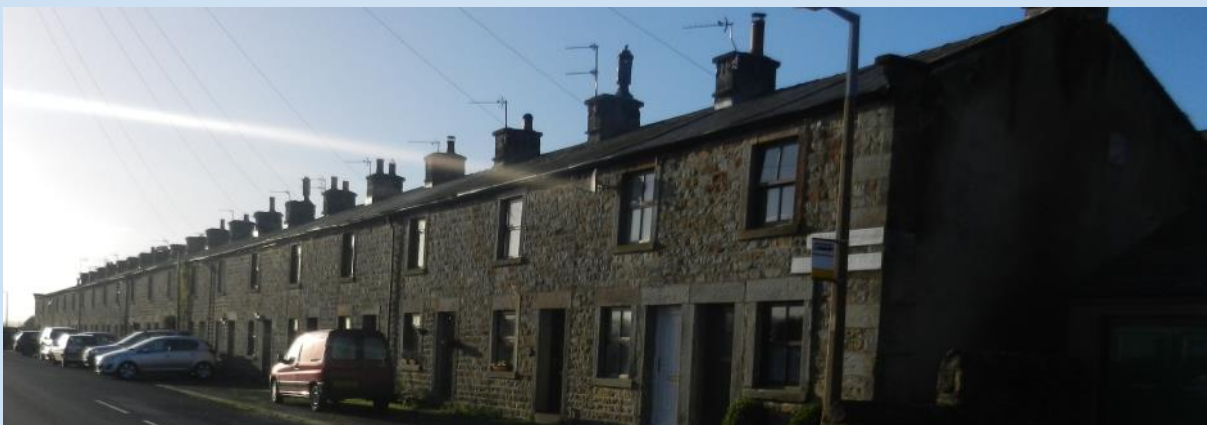
**Fig. 16** 1-18 Corless Cottages are two storey terraces constructed in coursed sandstone and grey slate roof. Each property has two windows, which originally would have been timber sliding sash, with stone surrounds. This terraced is located south east of 19-28 Corless Cottages, which are three storey grade II listed terraces.

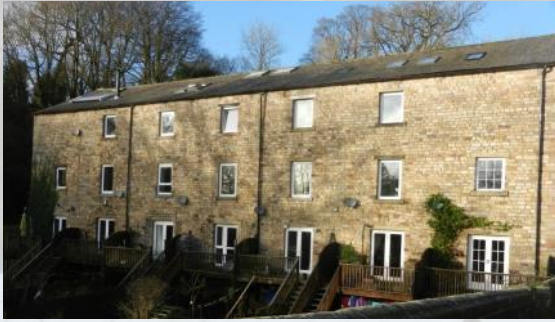
**Fig. 17** The 19th century warehouse was converted to housing in late-20th century.

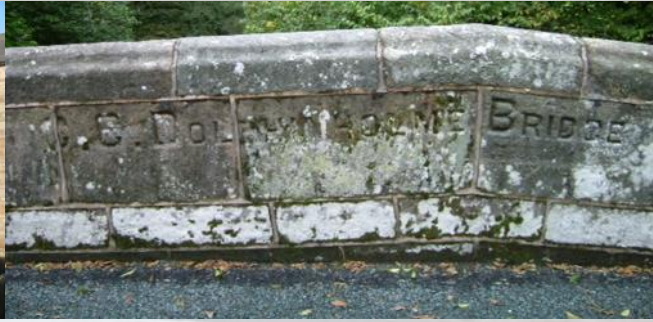
**Fig. 18** Dolphinholme Bridge dated 1791 is constructed in sandstone ashlar with a segmental arch.

Bridge, 1791. Sandstone ashlar. Single segmental arch with alternately projecting voussoirs. 2 pairs of end piers. String course below solid parapet with shaped coping. On the upstream side at the northern end a voussoir is inscribed: 'S. Law 1791'. The soffit of the arch has many masons' marks.

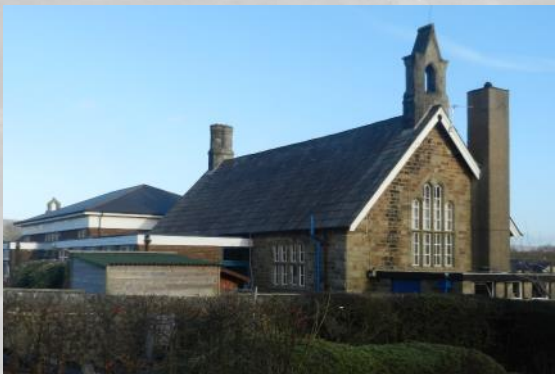
**Fig. 19** Dolphinholme CoE Church constructed in 1865 in a Gothic-revival style, was funded by the owners of Dolphinholme mill.

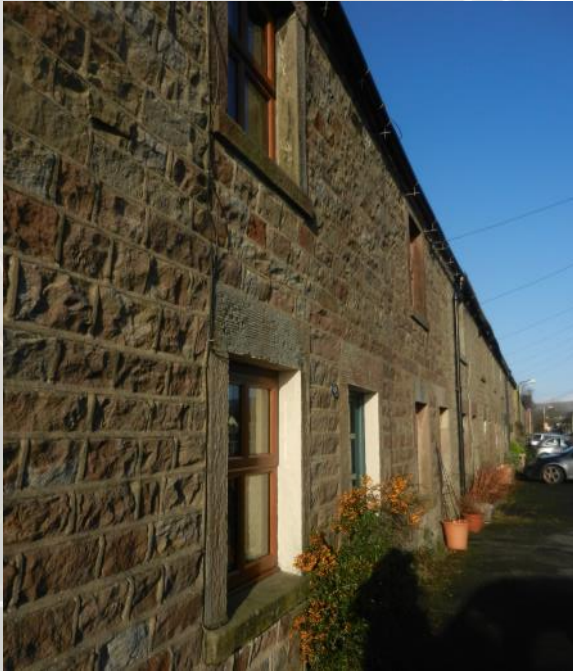
**Fig. 24** Sandstone walling predominantly characterises the historic buildings in Upper Dolphinholme, some are also traditionally rendered along Wagon Road.

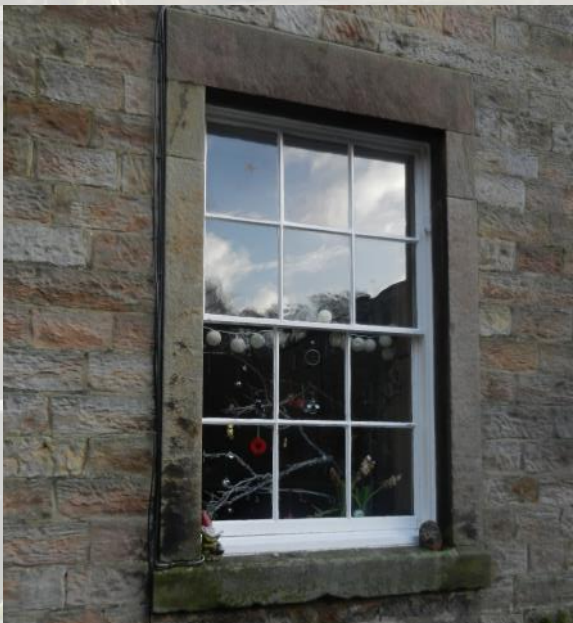
**Fig. 25** Traditional early-19th century timber sliding sash window with slim glazing bars. Such features contribute positively to the historic architectural interest of the area.

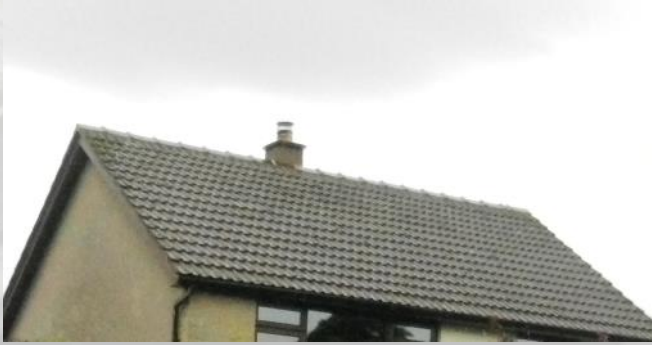
**Fig. 26** Contemporary unnatural materials such as concrete pantiles for roofing.

Although there are a variety of building types, there is a sense of unity between the historic and pre-20th century buildings as they are chiefly constructed in sandstone with a grey slate diminishing coursed roof. Originally, the windows of these buildings were timber sliding sash with stone surrounds and doors were timber panelled also with stone surrounds. However, some of these traditional details have been replaced with modern unsympathetic materials and styles in many unlisted historic buildings. This has negatively impacted the historic legibility of these buildings.

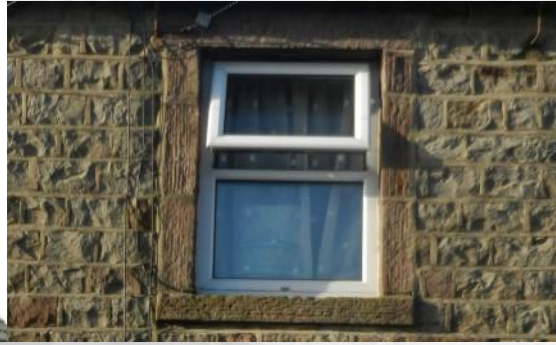
**Fig. 27** Replacement of traditional timber sliding sash windows with PVCu alternatives.

The assessment of the conservation area has identified it as in a relatively stable condition as no listed or unlisted buildings were identified 'at risk'. However, inappropriate alterations of architectural detailing, such as windows and doors, has negatively impacted the special historic and architectural interest of parts of Upper Dolphinholme's conservation area. To enhance the area's special interest, owners and developers should be made aware of conservation issues such as appropriate repair and alteration of historic timber sliding sash windows and panelled doors. Appropriate changes in architectural detailing will greatly improve the area's character.

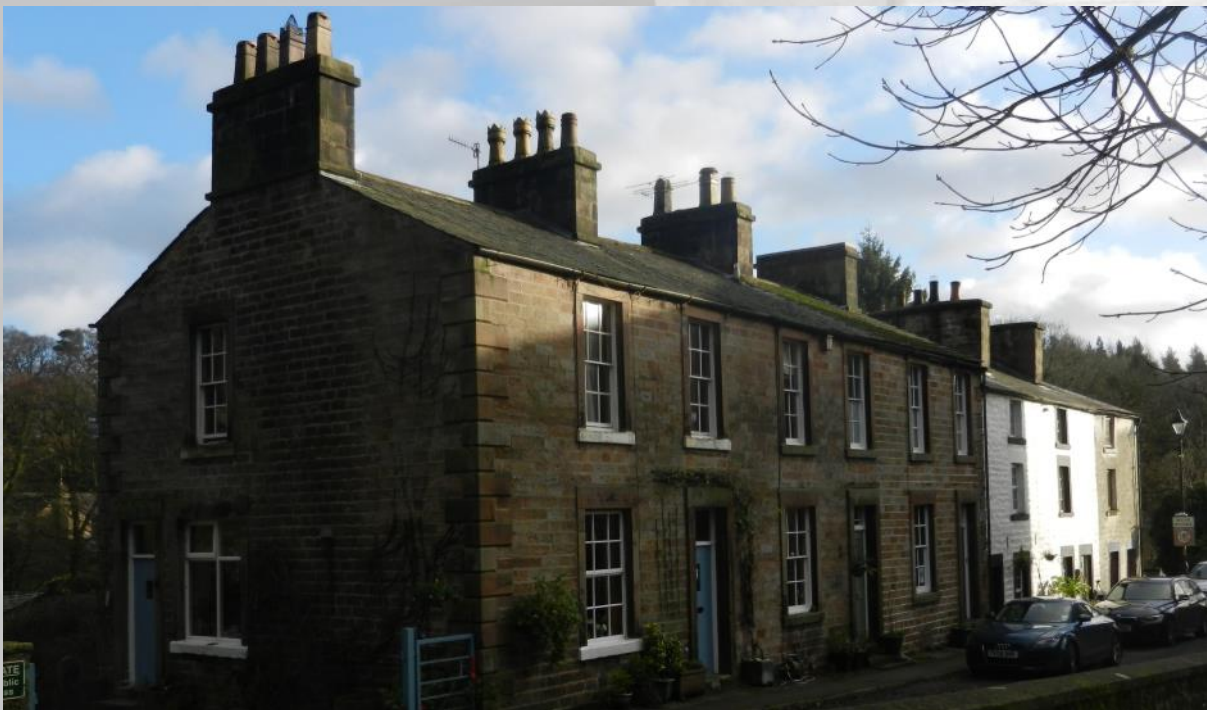
**Fig. 28** Wagon Road terraced housing early 19th century - constructed in traditional materials such as sandstone, render and slate.

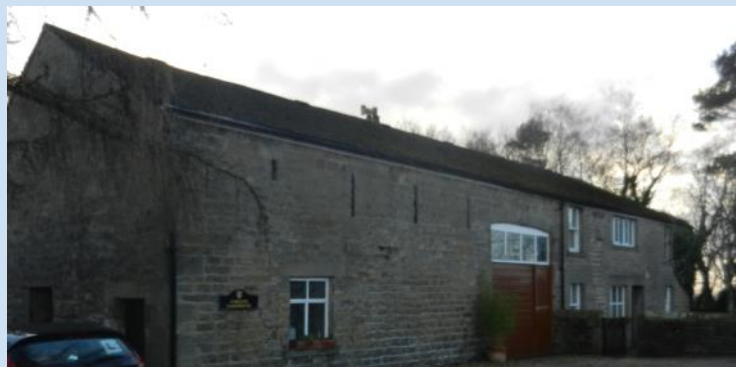
**Fig. 32** Corless Farmhouse with attached barn traditionally constructed in sandstone. Agricultural details, such as breather holes and a segmental barn door opening, are still visible.

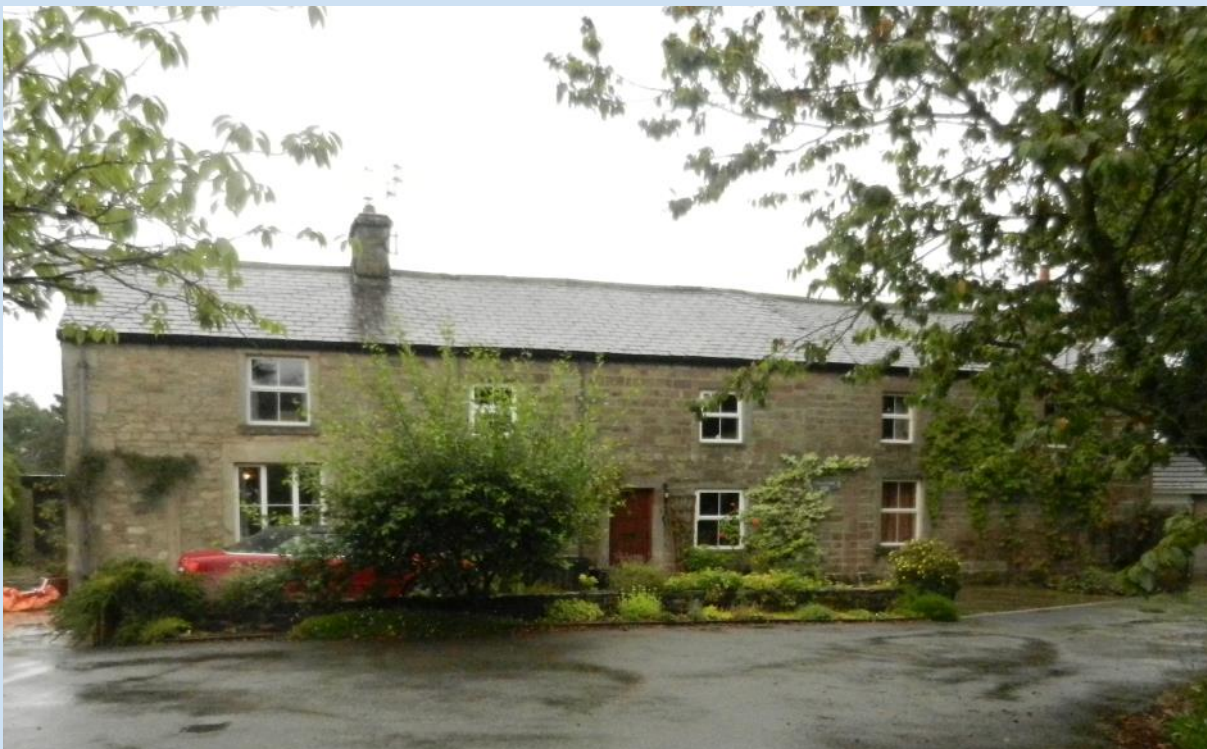
**Fig. 33** Common Bank House constructed in random coursed sandstone and grey slate roof. Originally the property may have been a long house but has been largely extended and altered with the addition of windows, doors and chimneys.

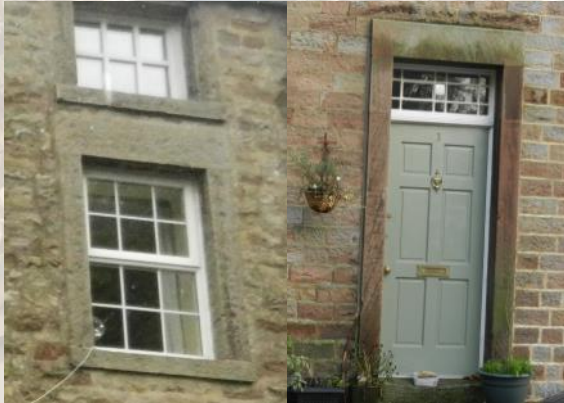
**Fig. 34** Traditional sash windows have been replaced with modern upvc.

**Fig. 35** Traditional timber panelled door has been retained.

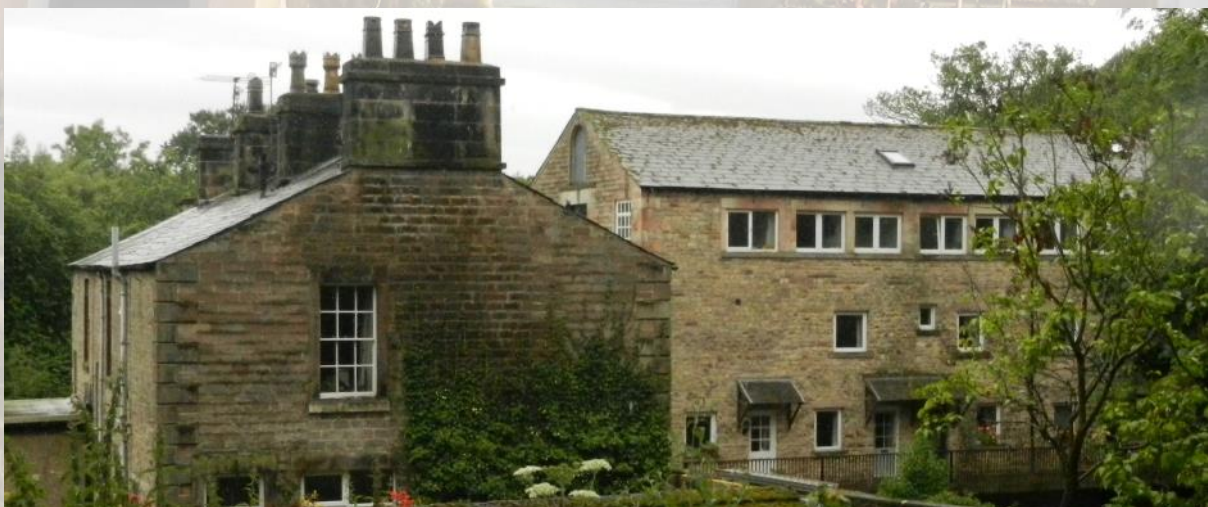
**Fig. 36** Early-19th century Wagon Road terraced housing in the foreground and the former Dolphinholme warehouse in the background were constructed as a result of the industrialisation of Dolphinholme.
