Melling

# Conservation Area Appraisal

Adopted February 2016

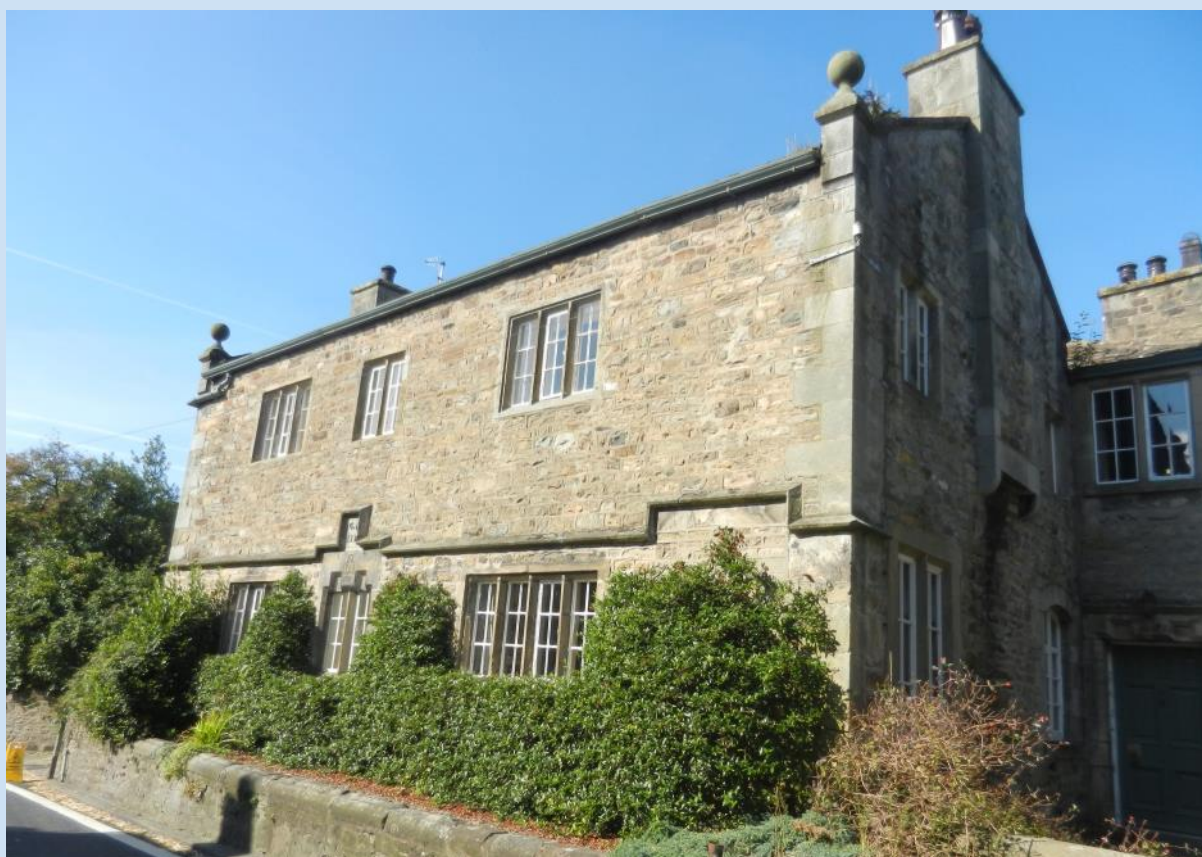
Fig. 4 Church Gates is grade II listed vernacular constructed house. The house, dated 1885, was likely a rebuilding of a late 17th century house as there remains a datestone of '1661' above the former doorway.

House, 1885, probably rebuilding a house of 1661, parts of which remain. Sandstone rubble with slate roof. 2 storeys, 3 bays. Windows mullioned, rebated and chamfered and of 3 lights, except for the central one on the 1st floor which is of 2 lights and chamfered, and the right-hand one on the ground floor which is of 4 lights. Some of the mullions have been extended. A drip course rises over the former doorway in the central bay and over a blocked opening at the right. The former doorway is now a window with a central mullion and has a chamfered surround with a battlemented lintel inscribed: 'TMT 1661' and 'GR.1885'. The gables have chimneys and copings with kneelers and ball finials. The left-hand stack projects, the right-hand one projecting on stone corbels at 1st floor level.

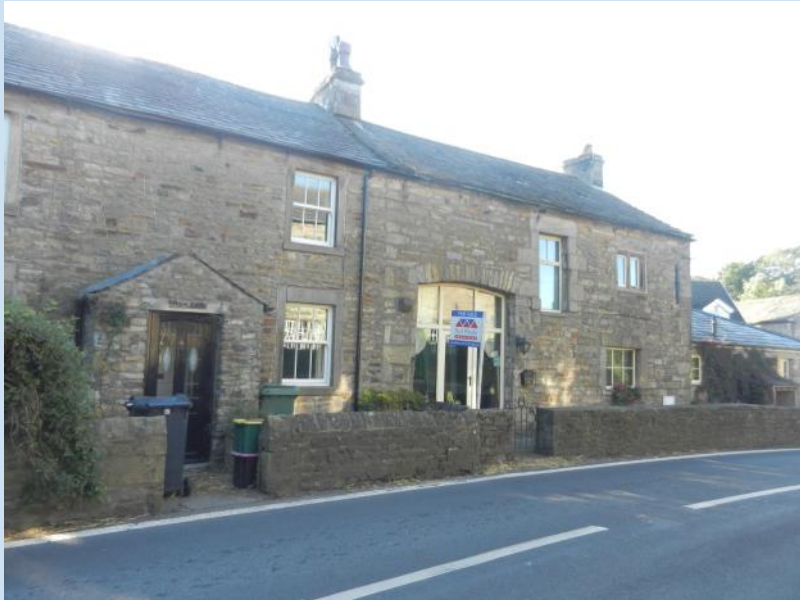
**Fig. 8** Ash Lea and The Old Forge are traditionally constructed in sandstone with slate roof. The Old Forge has retained architectural detailing of its previous agricultural use as a barn with the segmental arched opening.

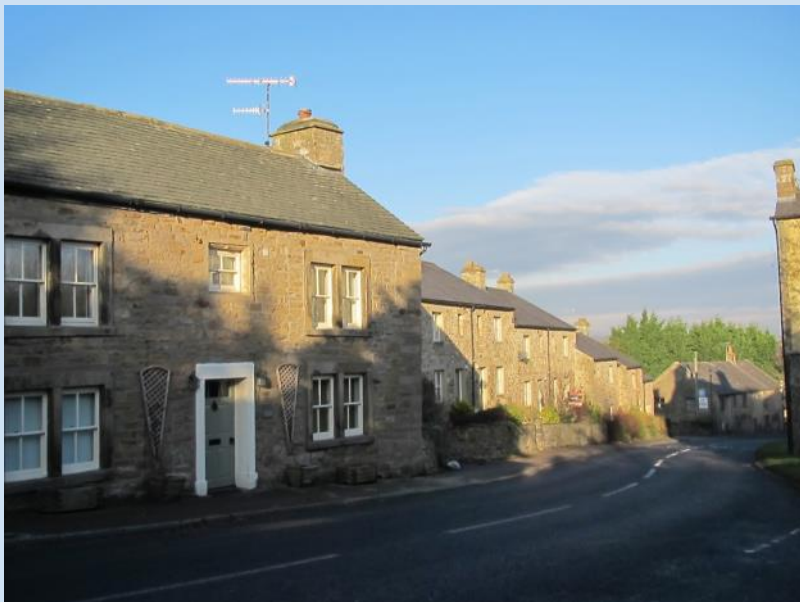
**Fig. 9** Crow Trees farmhouse in the foreground is a 17th century farmhouse constructed in sandstone rubble and grey slate roof. Melling Brow in the background is modern terraced housing development which positively responds to the vernacular expression of Melling's conservation area.

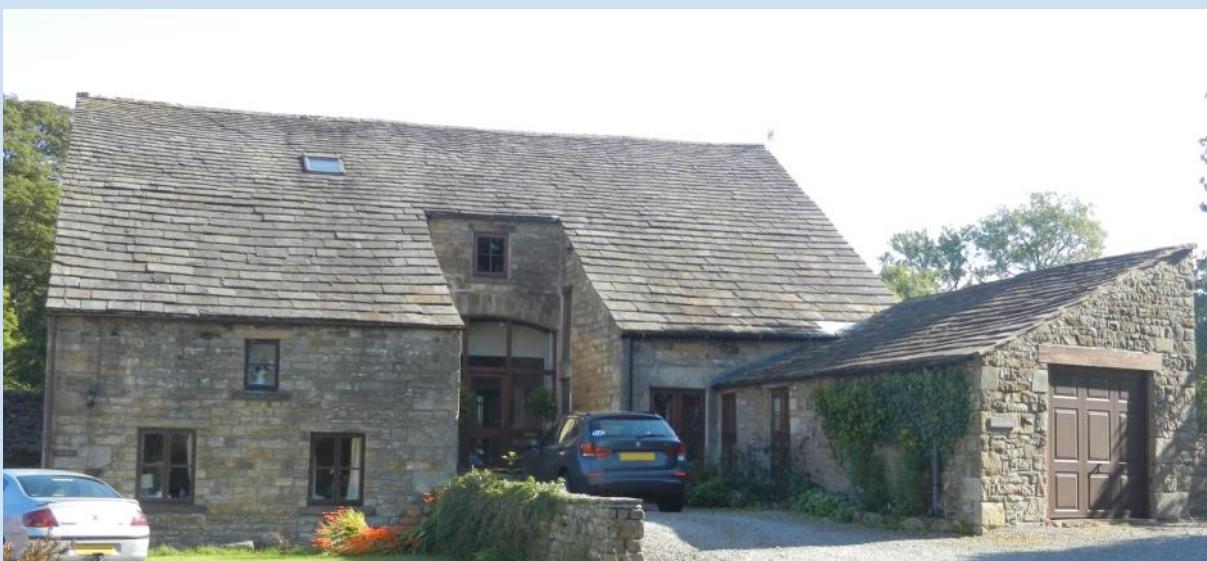
Fig. 14 Underhill is a late-18th century barn constructed in sandstone with a stone slab roof. In the late 20th century it was converted to residential use.

Barn, 1795. Watershot sandstone with stone slate roof. Original outshut on south-west side, with recessed wide entrance with segmental arch. To the left are breathers on the ground floor and a pitching hole with plain reveals above. To the right is a door with long-and-short jambs. The left-hand gable wall, facing the road, has 3 shippon doors with long-and-short jambs, and a similar door to the right to the outshut. Between and above the doors are breathers. Under the apex is a semi-circular keyed opening with plain stone surround. Above it is a circular owl hole with a stone surround inscribed: 'RR 1795'.

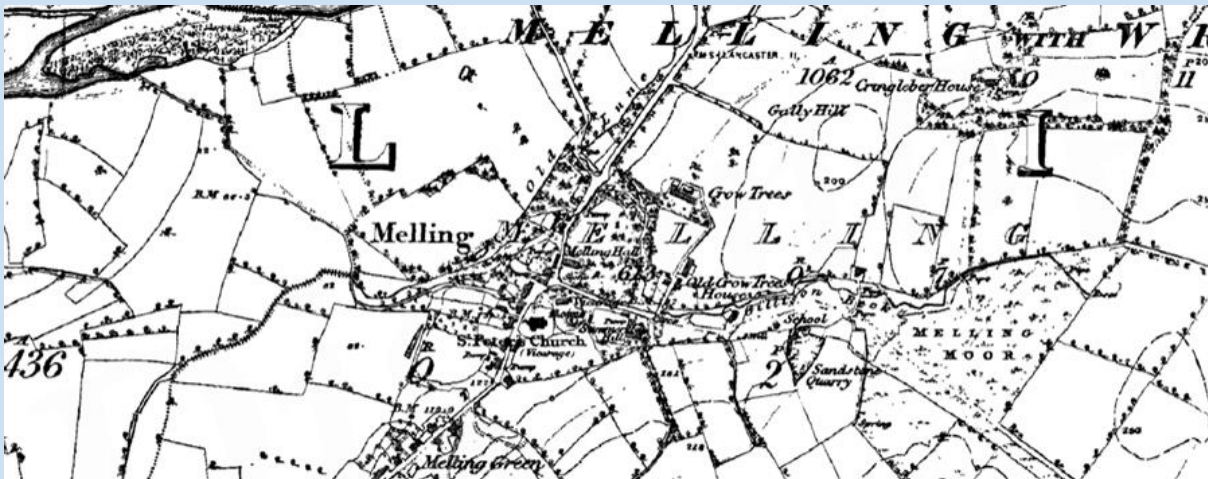
Fig. 15 1840s OS map (1:7500) of Melling, which demonstrates the historic settlement plan that has largely remained intact.

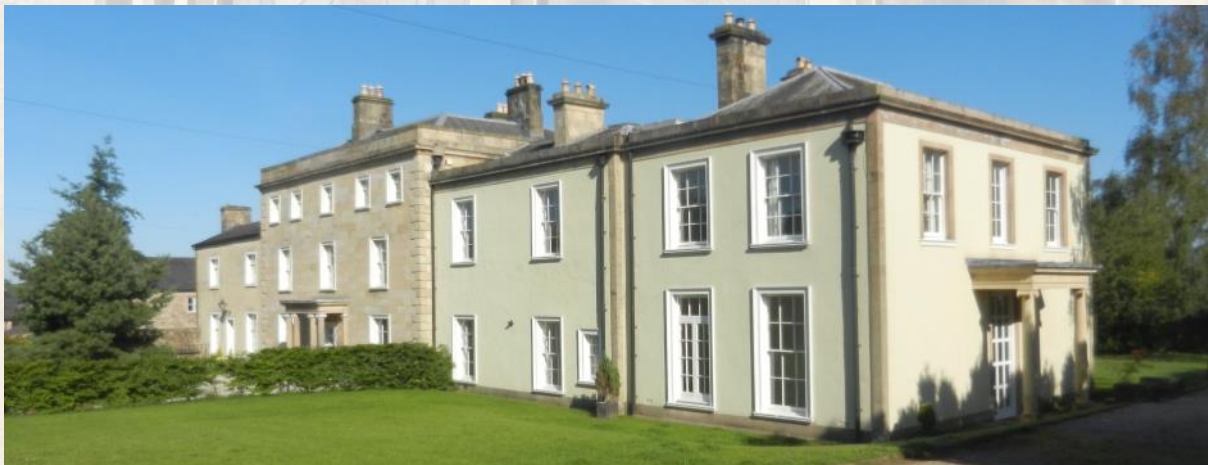
**Fig. 19** Melling Hall is a mid-18th century house which demonstrates the Georgian era's neo-classical architectural influence.

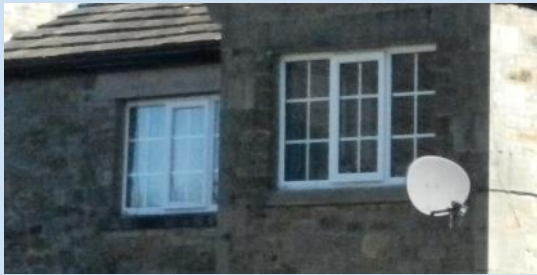
**Fig. 20** Modern satellite dishes and PVCu windows negatively impact historic interest of parts of Melling's conservation area.

Modern features, such as highways signage, satellite dishes and antennas, have negatively impacted the setting of some listed buildings and the special interest of the conservation area. In general, properties have been well maintained and are in a good condition. However, the assessment of the conservation area has identified some features such as vegetation growth on roof as a potential long term risk to the buildings. In addition, one unlisted building was identified as vacant in the assessment which if prolonged could lead to the long term deterioration of the building and negatively impact the character of the conservation area.

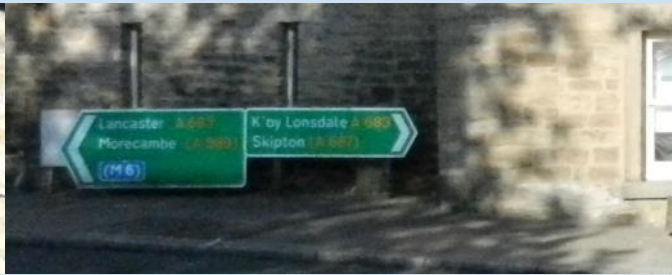
**Fig. 21** Highways sign negatively impacts this listed building and the character of buildings in conservation area.

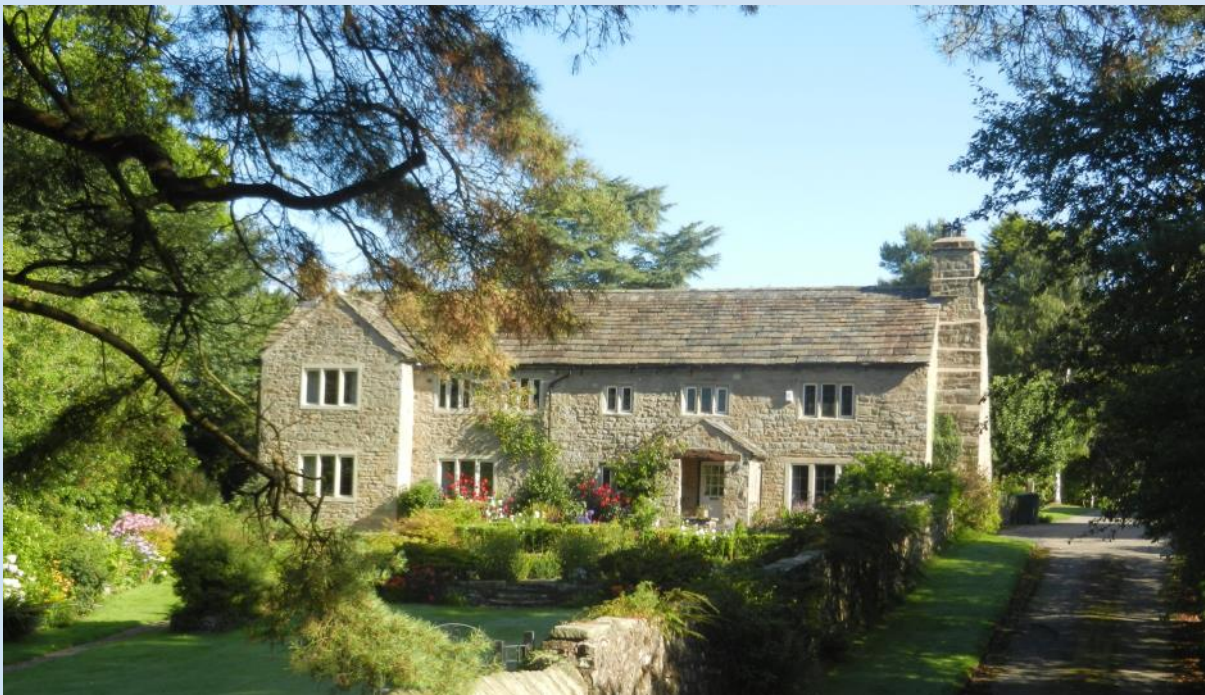
**Fig. 24** Old Crowtrees dates from late 17th century, constructed in rubble sandstone with a stone slab roof to the front with a large projecting chimney stack to the right. To the left a gable projecting extension was constructed in a sympathetic style in the late-20th century.

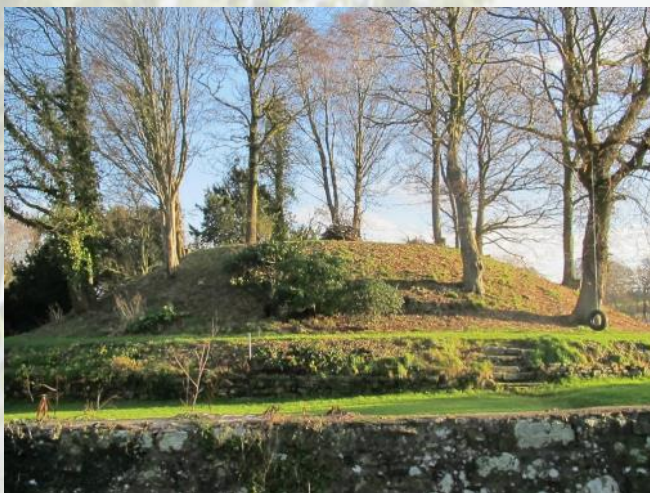
**Fig. 25** Castle Mound Motte became a scheduled monument in 1953 for its historic interest and connection to the Norman conquest of England. The remaining motte castle at Melling was part of a group of post-conquest mottes along the Lune Valley.

Within the conservation area there is a scheduled monument of the Castle Mound Motte located east of St Wilfrid's churchyard. The motte and bailey was a medieval fortification introduced by the Normans after the conquest of England in the 11th century. The motte and bailey at Melling was twinned with the motte at Arkholme and was part of a larger network along the River Lune to control movement along the Lune Valley. It is believed that this network was the second largest during the 11th century.

Melling's Castle Mound Motte has been retrospectively landscaped to include a terrace and the bailey has been partially lost. Nonetheless, the site provides a potential resource for future archaeological research or interpretation.

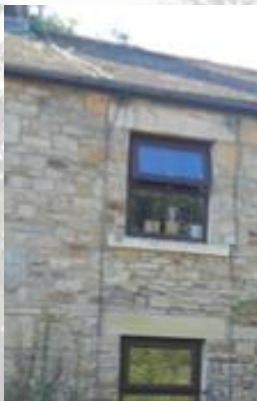
**Fig. 30** Inappropriate alteration to windows to a mock sash style.

Detailing, such as traditional sliding sash or casement windows, should be retained as these features can provide evidence of the period of construction of a building and, if lost, could erode the architectural and historic interest and legibility of the conservation area. Some inappropriate alterations have occurred to mock-style sash windows with a casement opening. Thus far the impact of these alterations has not been detrimental but if continued this could lead to the devaluation of the importance of the area's built heritage.

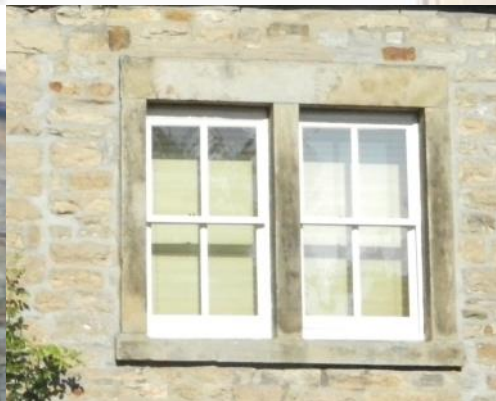
**Fig. 31** Retention of traditional timber sliding sash windows contribute to the historic interest of the area.

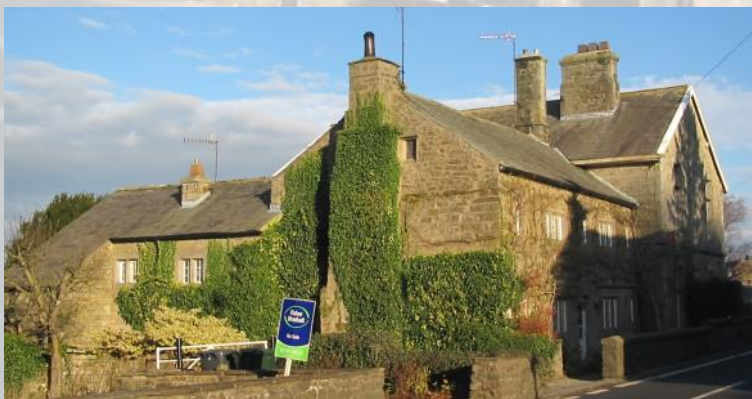
**Fig. 32** The Old Malt House dates from 1684 and is of significant historic interest as it was constructed as a late-17th century inn or malthouse.

House, 1684. Sandstone rubble with slate roof. A symmetrical composition of 2 storeys (originally with attic) and 4 bays, with rebated and chamfered mullioned windows and a drip course over the ground floor. The outer bays have one-light windows. The other windows are of 3 lights except for the central one on the 1st floor which is of 2 lights. The door has a moulded surround and an elaborate stepped lintel inscribed: 'ROBART V 1684'. End chimneys, the left-hand one with a projecting stack. The left-hand gable wall has a one-light chamfered attic window. Interior has pitch pine ceiling beams on ground floor and oak tie beam trusses on the 1st floor. An early example of a farmhouse with a symmetrical facade.
