Arkholme

# Conservation Area Appraisal

Adopted January 2016

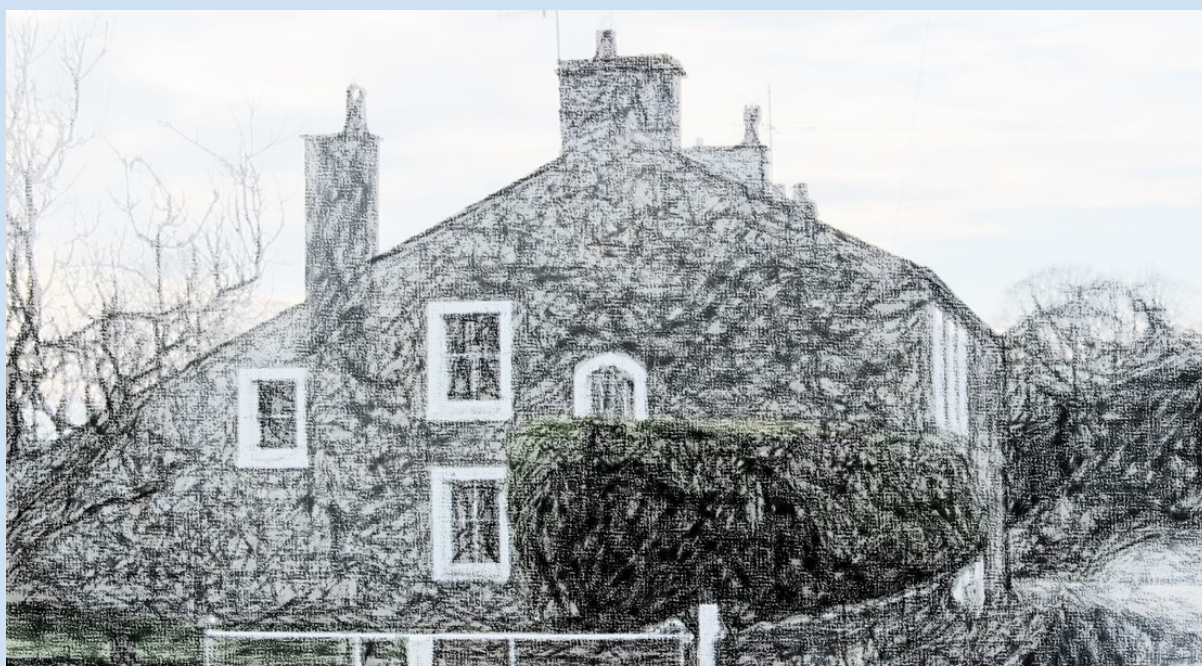
Fig. 2 Sketch of Chapel Cottages in Arkholme with a catslide roof on the outshut. The cottages have retained their architectural detailing, such as sash windows.

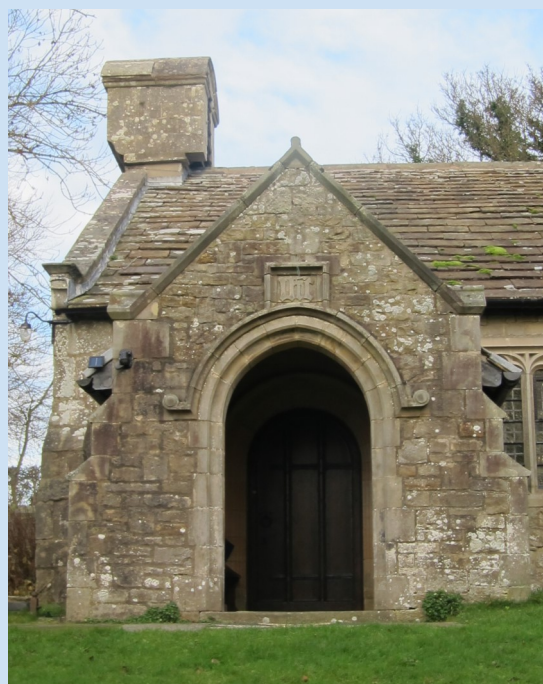
Fig. 4 St John Baptist church is grade II\*. The building has parts which date back to the 15th century. A lot of the church was restored by local architects Austin and Paley in the late 19th century.

The church of St John the Baptist is situated at the south easterly edge of the conservation area boundary. It is Grade II\* listed building and significantly contributes to the historic importance of the area. Much of the church was restored by local architects, Austin and Paley in the 19th century, but the church still retains some parts which date back to the 15th century. It also relates to the vernacular expression of the village's built environment through the use of random sandstone rubble walling and stone slate roofing.

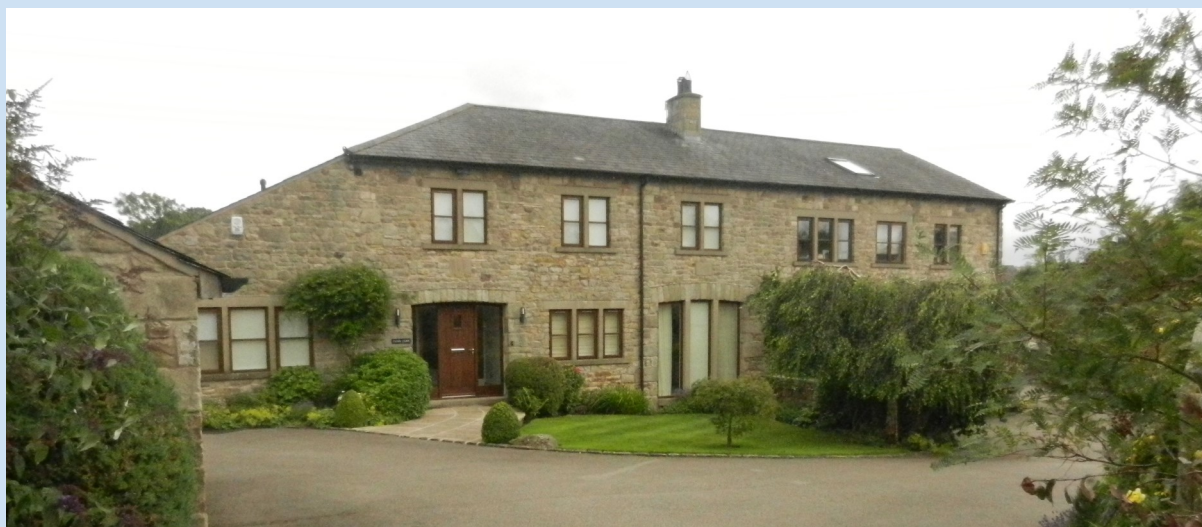
Fig. 5 Goss Lodge appears on the 1845 OS map as part of the land of Goss House. It has been converted to residential use, but like many other buildings in Arkholme it has retained its traditional barn door openings.

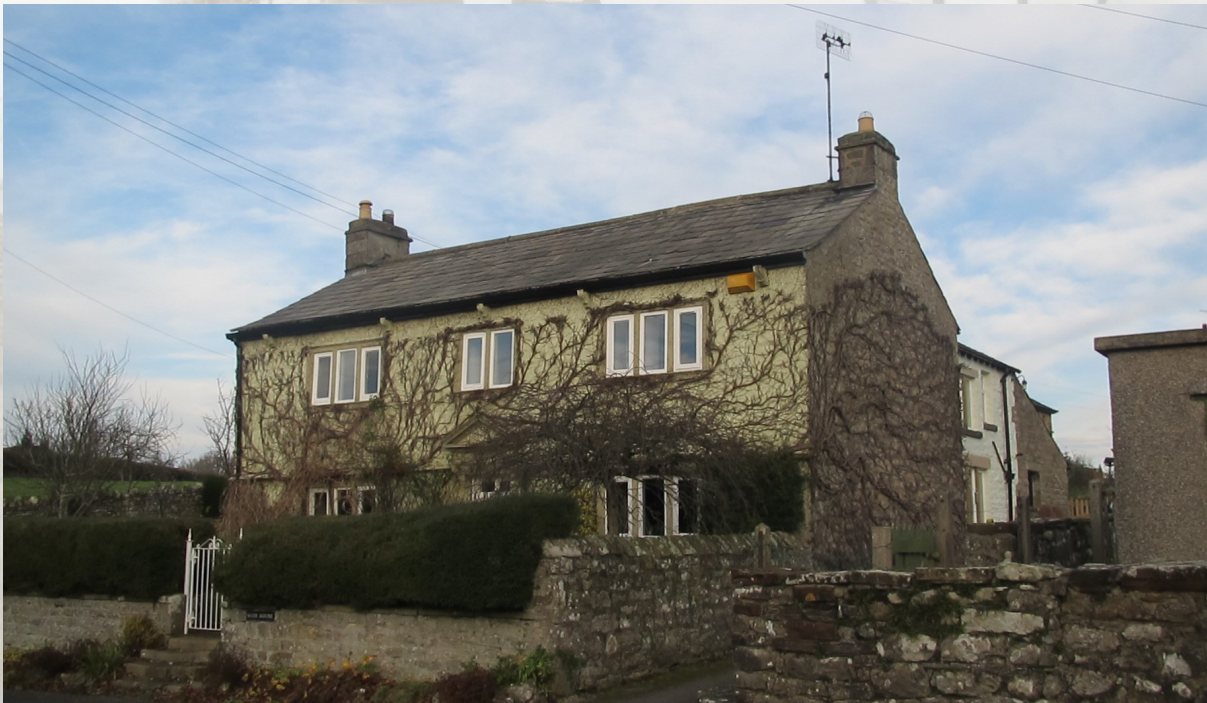
**Fig. 7** Goss House is a mid-18th century house, which has been traditionally rendered. The house shows influence of international styles of classical detailing above the doorway with a dentilled pediment. However, the prevalent vegetation growth on the building could threaten the integrity of the built structure as the roots can penetrate joints and cause displacement of the stone.

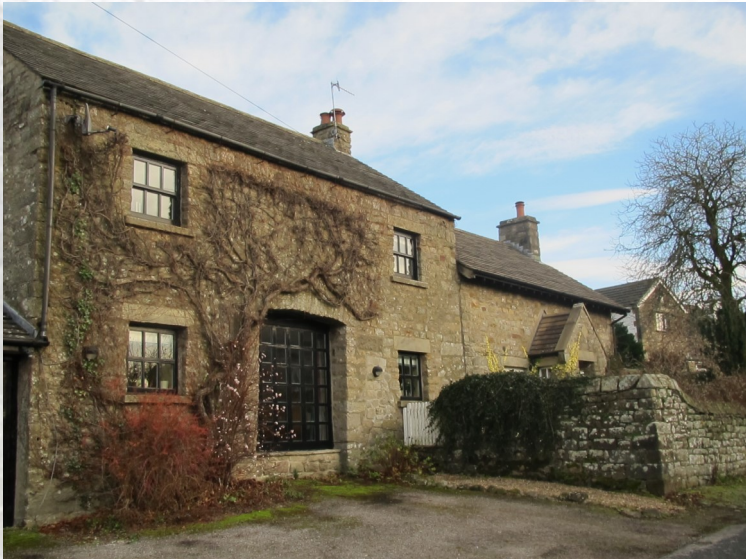
**Fig. 9** Architectural detailing associated with the previous agricultural use has been well maintained in Arkholme, as can be seen with the retention of the segmental arched barn door opening after the building was converted to residential use.

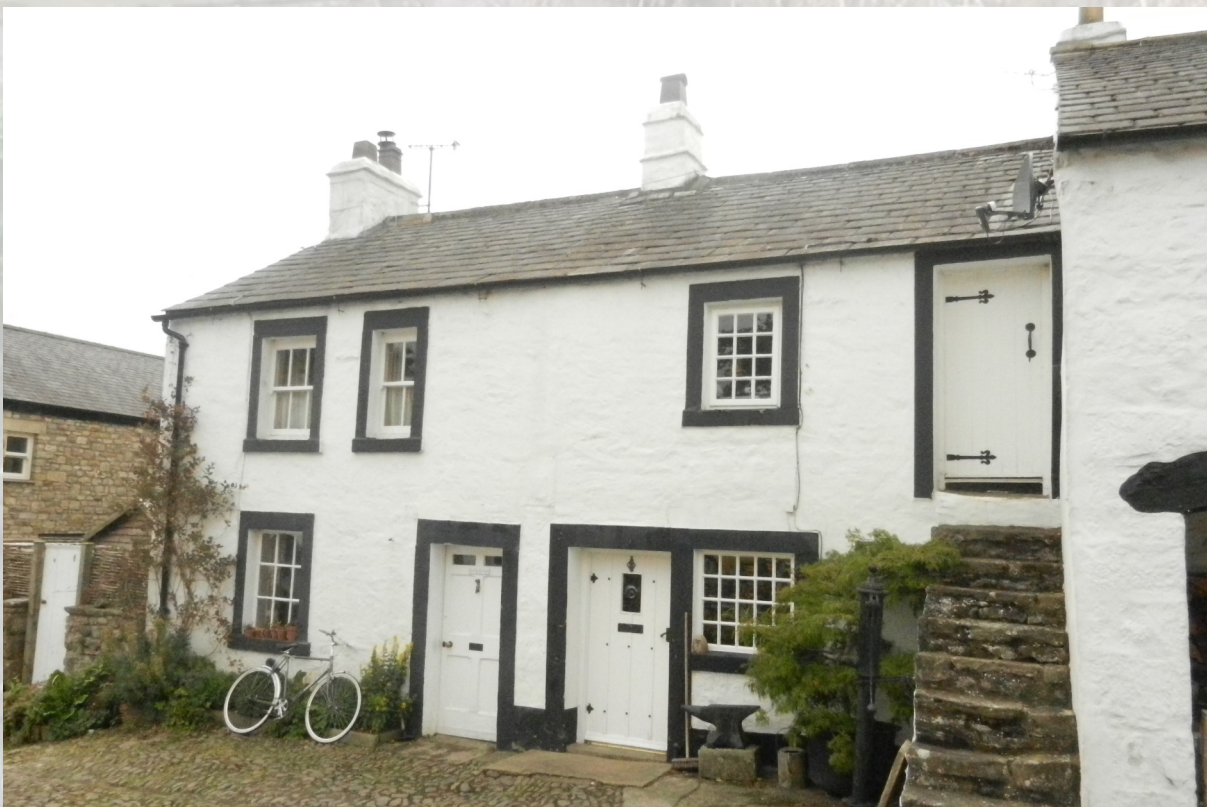
**Fig. 10** Smithy Cottage is a pair of houses and former smithy from the early-19th century, which have been traditionally rendered to create a distinctive black and white appearance.

Towards the north of the conservation area, the Bay Horse Hotel and Smithy Cottage provide examples of the rendered building tradition which is emphasised by the black painted quoins and stone surrounds to the openings. On the opposite side of the road, a typical Victorian revival style school with pointed arch windows.

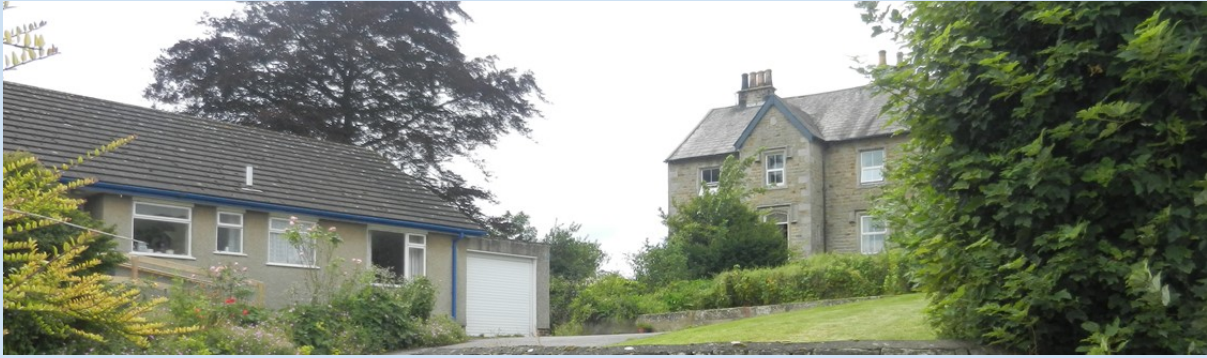
**Fig. 11** Modern bungalow in a non-traditional style in the foreground of a positive unlisted building within Arkholme.

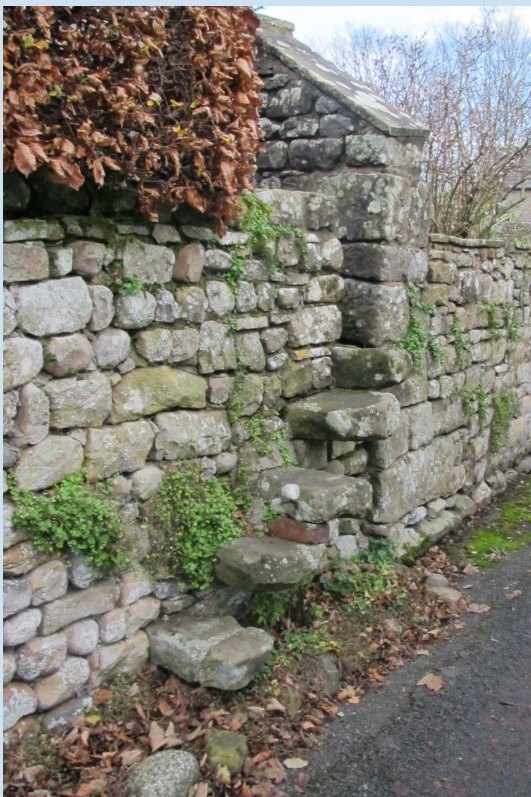
**Fig. 12** Traditional drystone boundary walls characterise the village of Arkholme, some with flat coping stones.

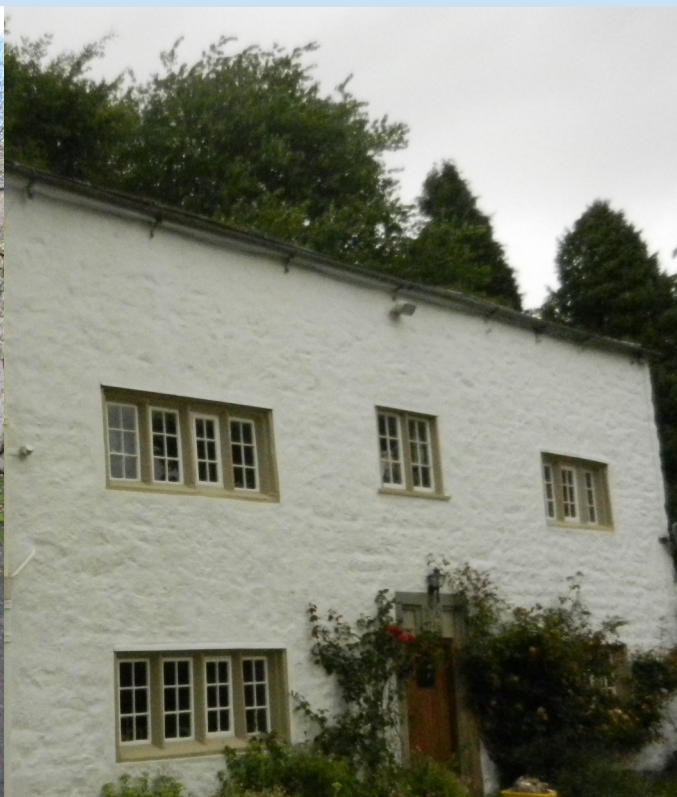
**Fig. 13** Luneside, previously known as Lune Cottage, is a traditionally rendered house with a datestone of 1714 above the door.

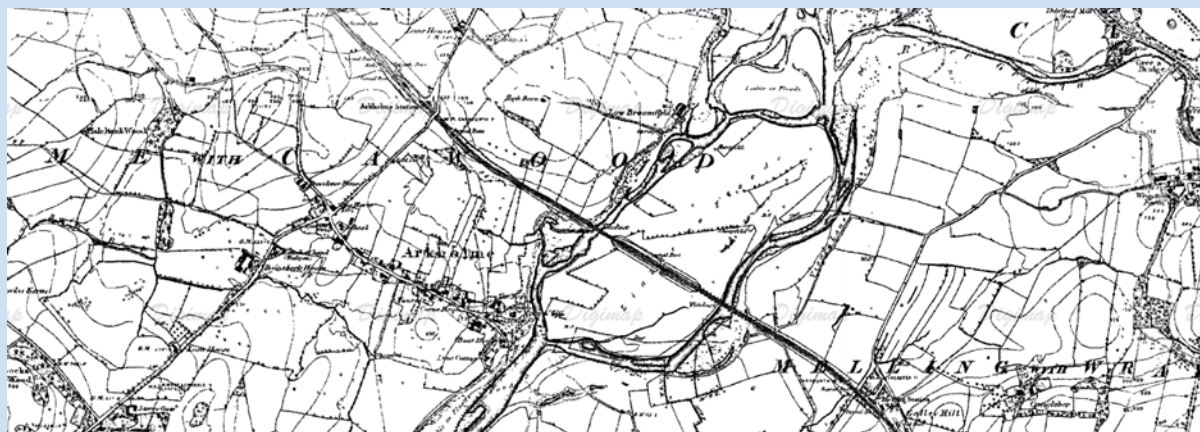
Fig. 16 OS map (1:10,000) of Arkholme in 1890, showing the linear settlement plan form and the development of the railway on the outskirts of the village.

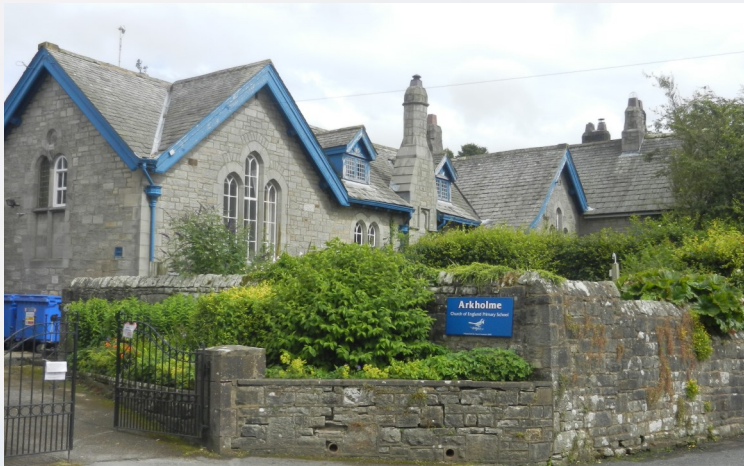
**Fig. 17** The school and schoolmaster's house were built in the mid-19th century, it demonstrates the end of the vernacular building tradition as architecture began to be influenced national revival styles, as seen with the pointed arch detailing of the windows.

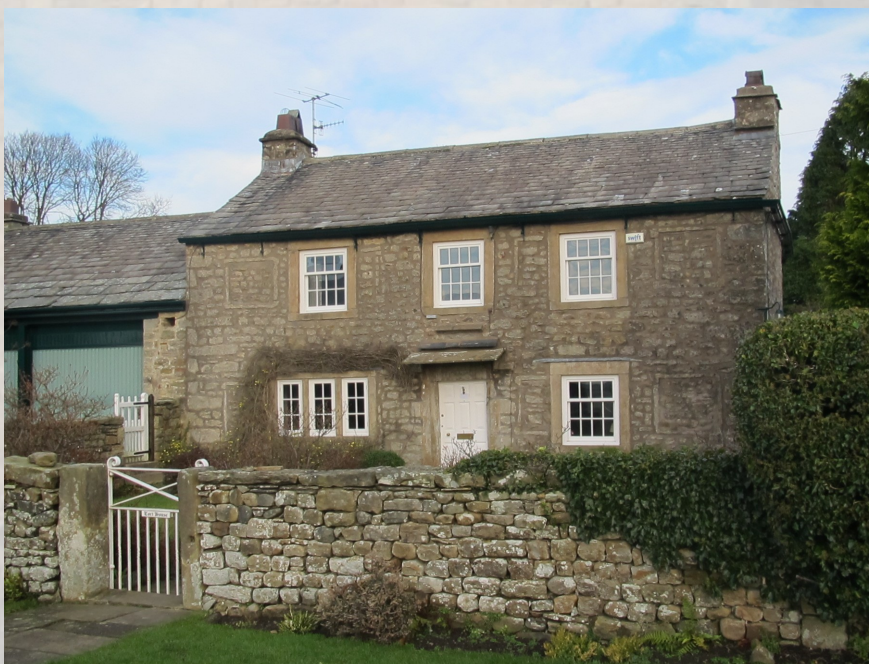
**Fig. 18** Cort House dates from 1700, it has been traditionally constructed in sandstone rubble with a slate roof.

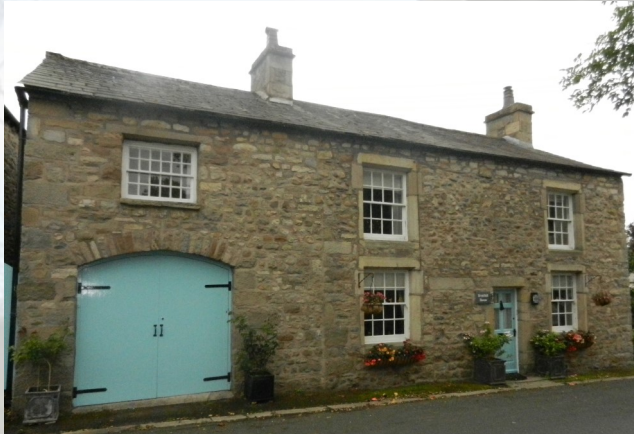
**Fig. 19** Brunt hill House was built as a farm building (on the left) and a dwelling (on the right) under the same roof.

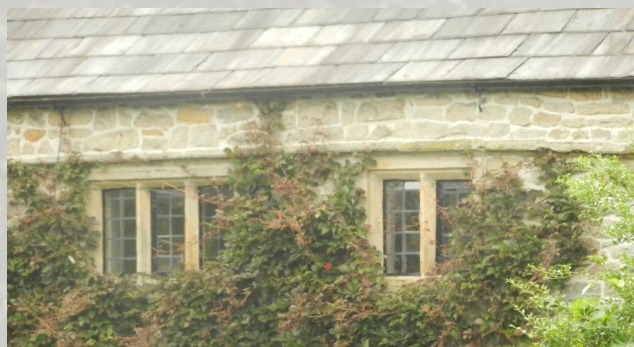
**Fig. 20** Mullioned windows have been well retained at Pool House and contribute to the historic legibility of the building.

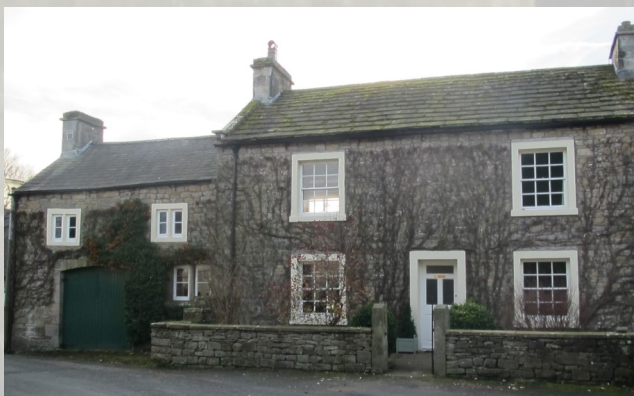
**Fig. 21** Traditional construction and good retention of architectural detailing, such as sash windows at Caulking House.

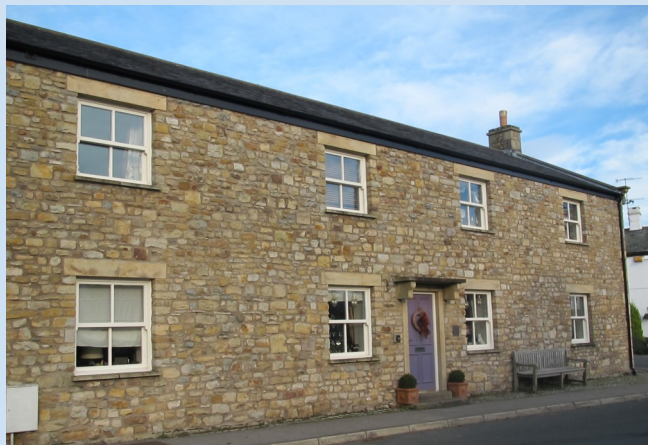
**Fig. 22** Modern housing fronting the main highway which responds well to Arkholme's vernacular character.

Some modern housing developments have responded to the local distinctiveness of construction using a similar massing and materials, with a contemporary plan form and arrangements. These modern buildings are evenly dispersed within the linear arrangement of the village. However, some modern housing has contrasted the character and developed unsympathetically in cul-de-sacs as they do not relate to the local geology or historic development of the village. Nonetheless, it is fortuitous the greenery and boundary walls which surrounds many of these properties minimises the extent of their negative impact on the historic character of the area.

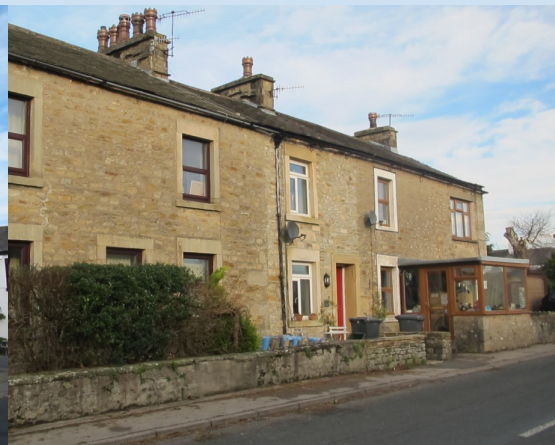
**Fig. 23** Use of non-traditional materials, such as upvc, for windows and doors negatively impacts the character of Arkholme's conservation area.

Architectural detailing, which crucially contributes to the historic character of Arkholme, has generally been well-retained. A very small proportion of unlisted buildings within the conservation area have replaced traditional windows and doors for modern unsympathetic alternatives, such as PVCu.

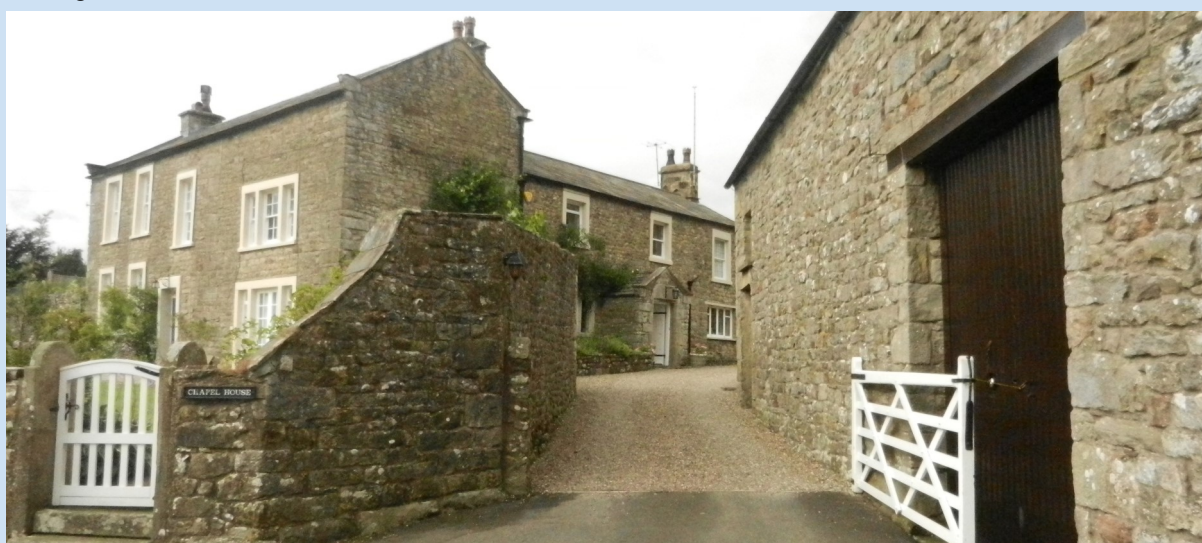
**Fig. 24** Church House and The Loft, previously known as 'The Nook' on 1845 OS map, constructed in rubble sandstone.

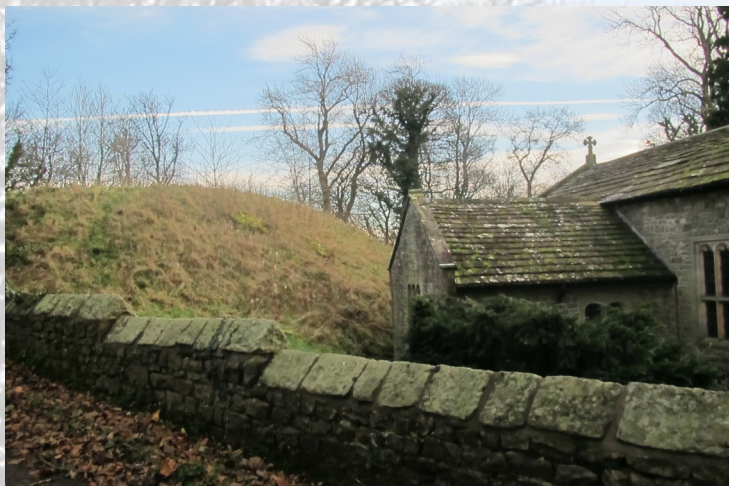
Fig. 25 Capel Hill motte is situated within the grounds of St John Baptist church.

Within the conservation area there is a scheduled monument of Chapel Hill motte, which was a medieval fortification introduced into Britain by the Normans after the conquest in the 11th century. This provides evidence that the village was occupied during this period and therefore has some archaeological potential, particularly to the east of the village, surrounding the Motte castle.

This was part of a network of motte and baileys along the Lune valley and it is suggested that Arkholme's motte is the best preserved example out of this network. This motte and bailey was twinned with the motte and bailey at Melling on the other side of the River Lune. The bailey, however, has been significantly disturbed by burials and activities within the churchyard.

The area surrounding the monument has become very enclosed with the development of the church and the boundary of the churchyard. Consequently, this area has limited potential as a resource for future archaeological research or interpretation of the site.

The monument at Arkholme comprises a truncated cone, the remnants of a medieval motte castle, situated on a commanding position dominating a slight bend in the River Lune overlooking an old river crossing. The motte lies in Arkholme churchyard immediately NE of the church, the vestry of which overlies the monument slightly on its SW. The bailey, which was originally attached to the motte, is now very indistinct as it has been considerably disturbed by burials and activities both within and beyond the churchyard. Because of the damaged state of this bailey it is not included in this Scheduling. The churchyard wall runs around the motte on the NW, N and E sides and acts as a retaining wall. This wall is excluded from the scheduling as is the corner of the vestry where it overlies the monument. The ground beneath the churchyard wall and the corner of the vestry, however, is included.

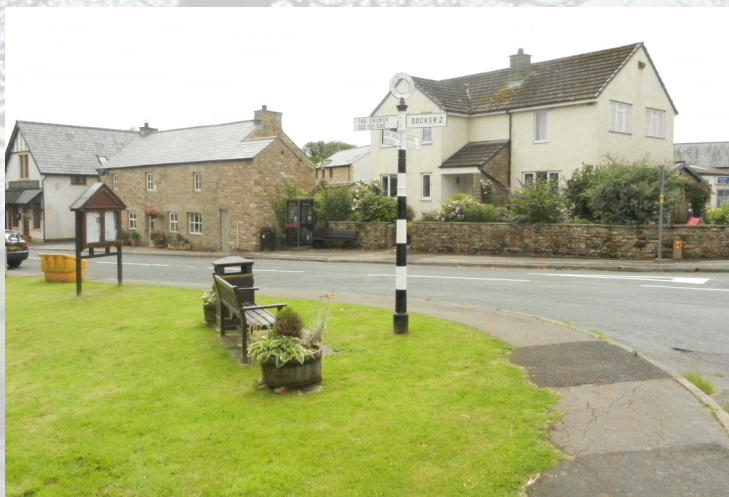
Fig. 26 Open spaces in the public realm are limited within the conservation area. There is an area of open space at the junction of Main Street with street furniture such as a bench, signpost and community noticeboard.

At the intersection between the two main roads, a small patch of open space is being utilised to offer community news. The lack of public space is likely to be enhanced by the recently constructed Village Hall

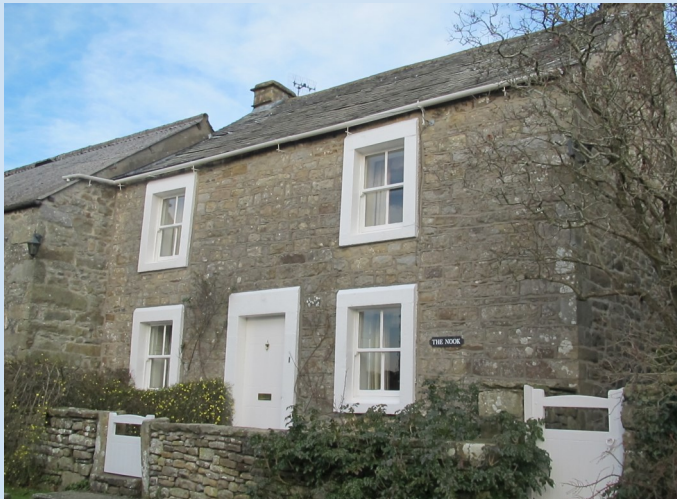
**Fig. 27** The Nook along Main Street is a symmetrical house with sash windows and stone surrounds. It contributes positively to the vernacular expression of Arkholme's conservation area.

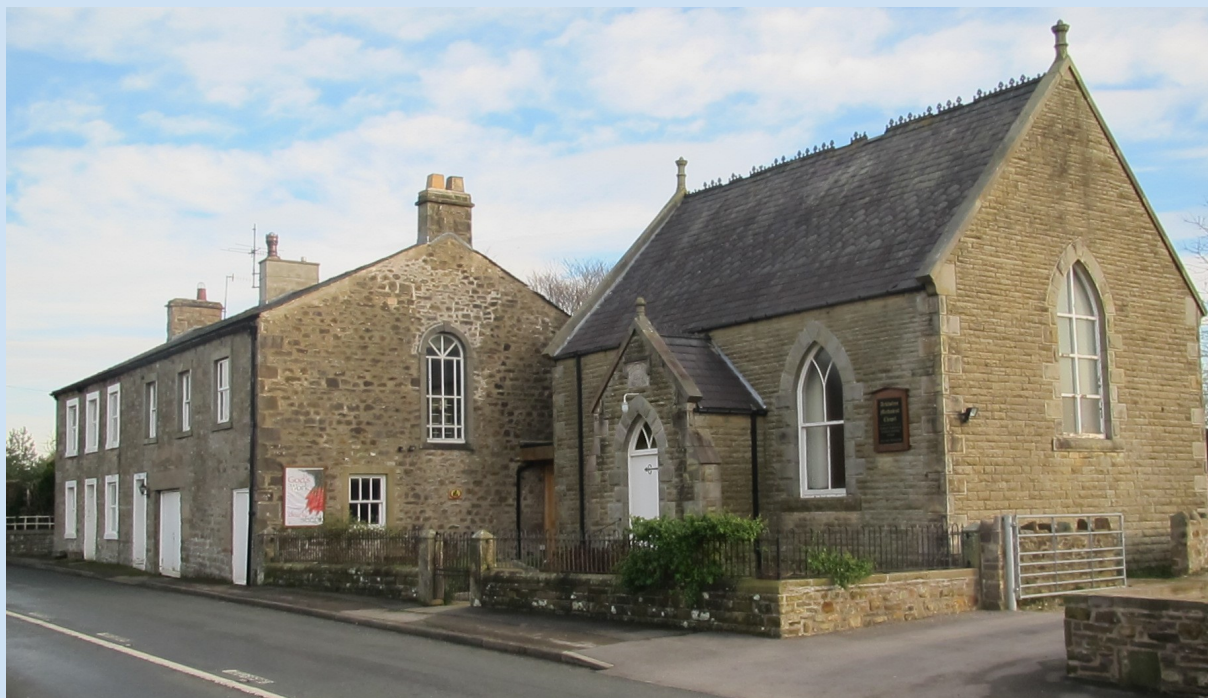
**Fig. 28** The Methodist Church (on the right) shows Gothic-revival detailing in the pointed arched windows and doors. The Chapel Cottages (on the left) are constructed more traditionally with an arched window on the gable end.

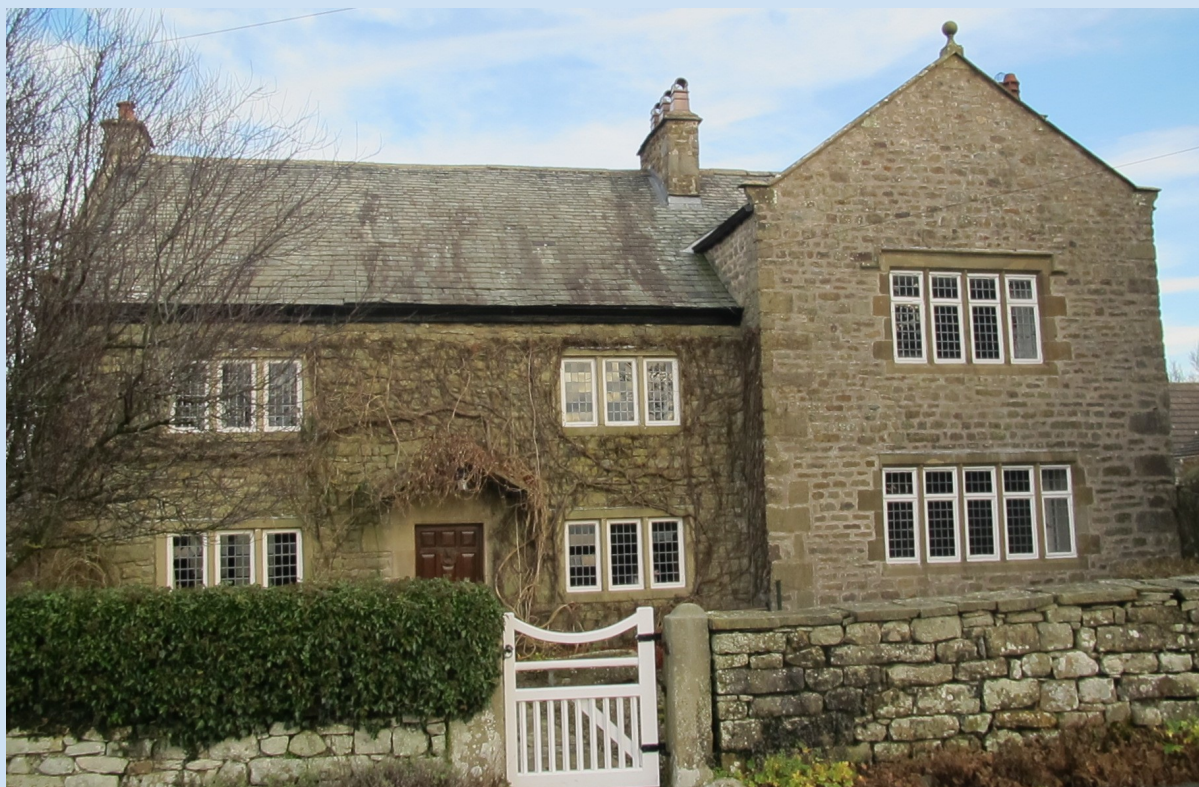
**Fig. 29** Cawood House contributes to the strong architectural quality of Arkholme through its retention of traditional windows and slates.

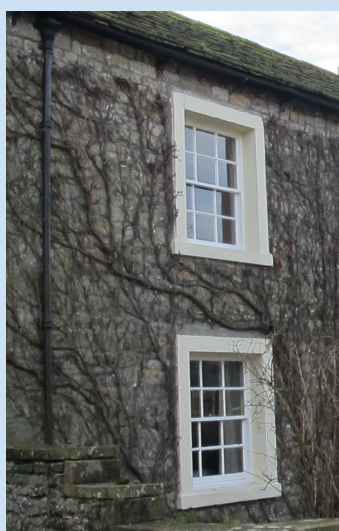
**Fig. 30** Caulking House retains the traditional 6-over-6 sash window fenestration.

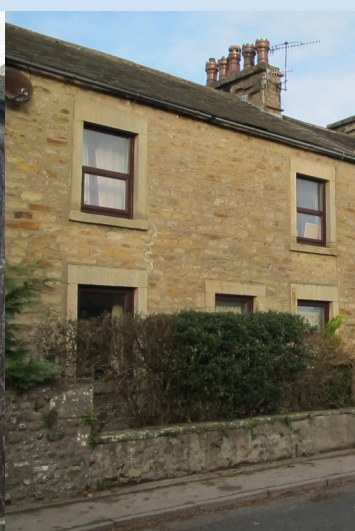
**Fig. 31** Some traditional sliding sash windows have been replaced with unsympathetic modern mock-sash casement opening windows.

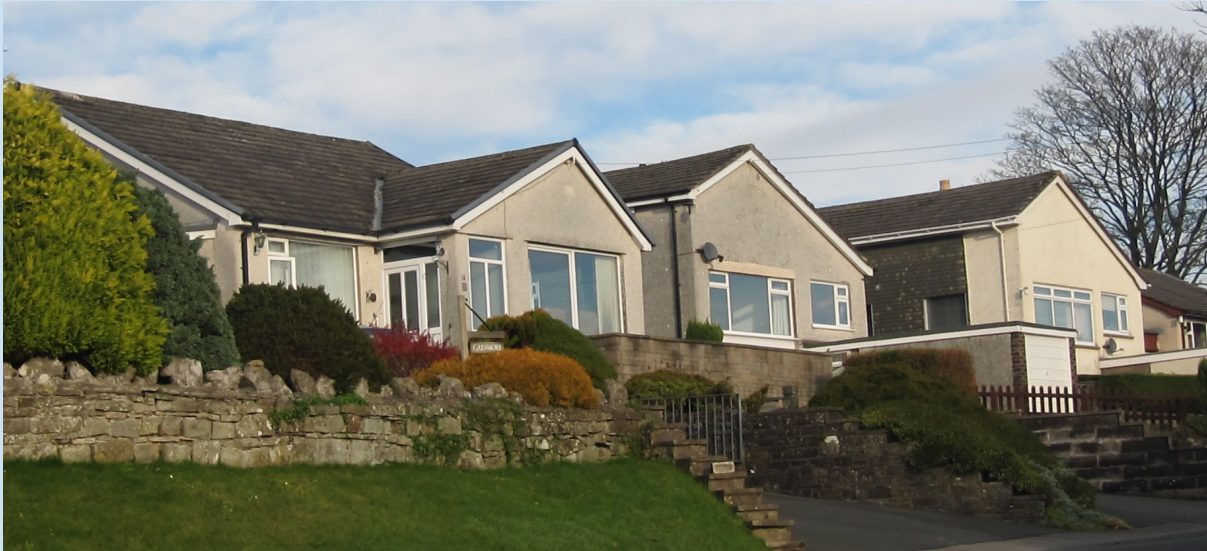
**Fig. 32** Some modern housing within the conservation area do not respond to Arkholme's distinctive vernacular construction.

Some insensitive housing developments which are uniform in their construction and disconnected from the local built tradition threaten to undermine the historic character and uniqueness to which the area was designated for. Continued unsympathetic developments will erode the architectural and historic interest. It should, therefore, be thoroughly understood how the village has developed historically and how the buildings were formed to best inform a sympathetic development design which preserves and enhances the architectural quality and individuality of Arkholme.

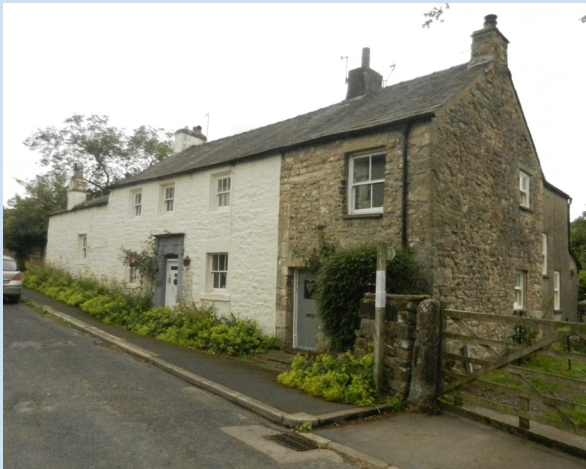
**Fig. 33** Meadowlands and Rose Cottage have strong aesthetic and historic heritage value.

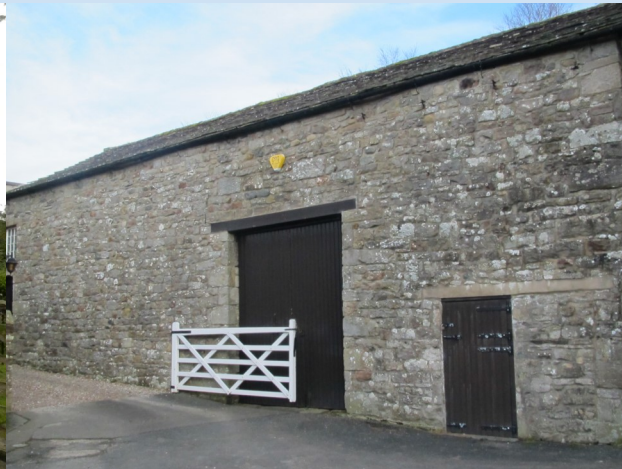
**Fig. 34** Agricultural use is still prevalent in the legibility of Arkholme's buildings.
